| VOLVO V40: 1EHK788 | | | |
| Vinnnumber: | <b>YV1MV8481D2017534</b> | Versionname: | <b>V40 D2 Base 115PK</b> |

| Limited Technical Inspection | | | |

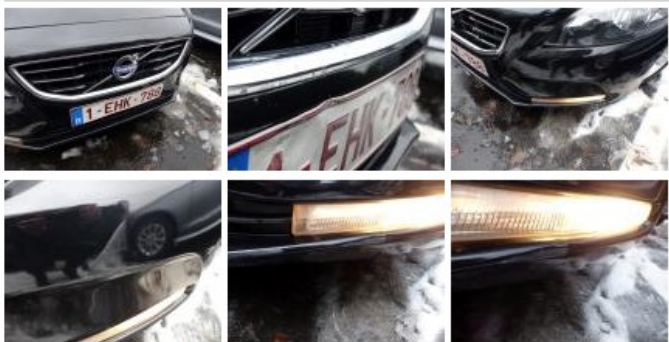
| Front bumper, Bump(s) and scratch(es), LI - Repair and paint (complete) | | | <b>283,80</b> |

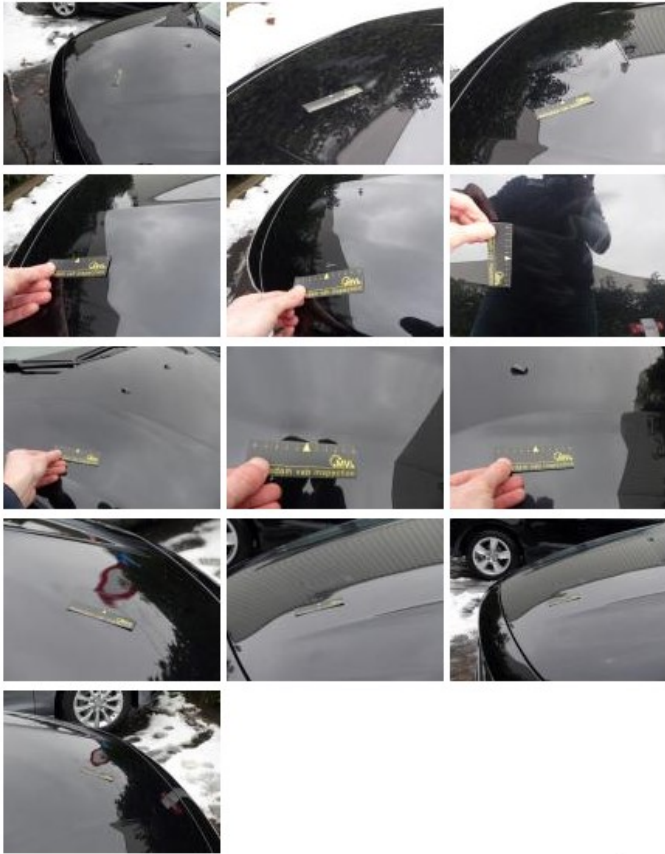
| Bonnet, Bump(s) and scratch(es), LI - Repair and paint (complete) | 290,08 |

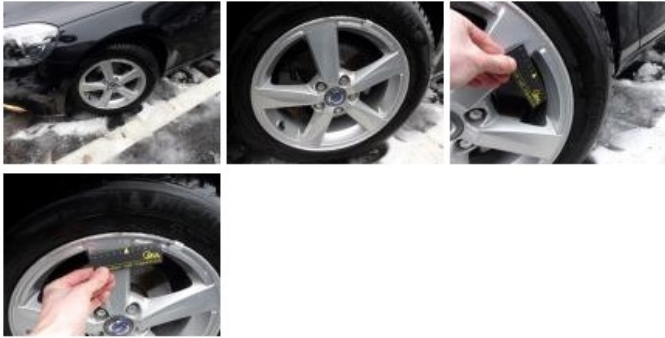
| Alloy rim F L, Scratch(es), LI - Repair and paint (complete) | 95,00 |
