| VOLVO S60: 1EHW148 | | | |
| Vinnnumber: | YV1FS84A1D2207629 | Versionname: | S60 BER D2 Kinetic St/St |

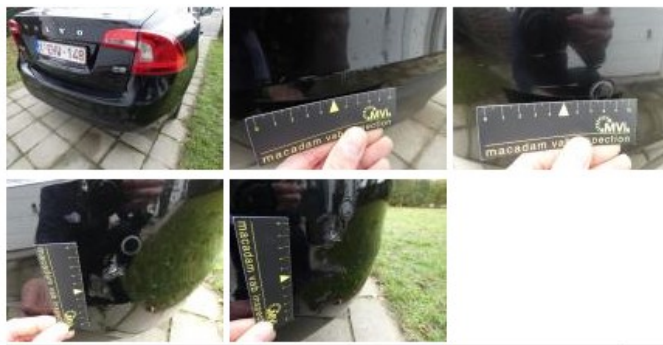
| Bumper R, Bump(s) and scratch(es), LI - Repair and paint (complete) | 211,80 |

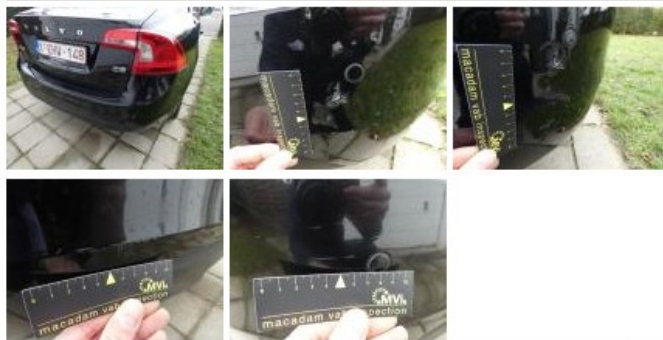
Bumper R, Bump(s) and scratch(es), Smart repair 110,64

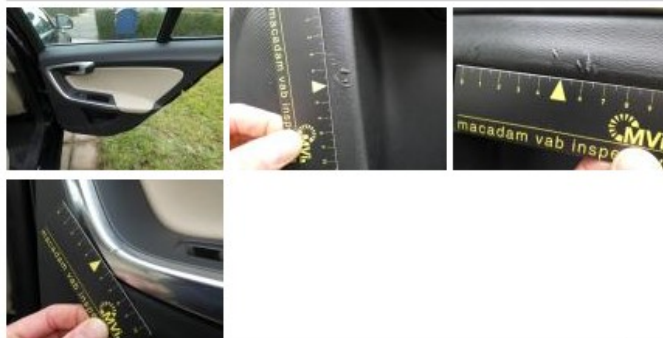
Door panel R R, Scratch(es), Smart repair 110,64
