| CITROEN C4 Picasso: 1EDI066 | | | |
| Vinnnumber: | VF7UARHB8CJ727668 | Versionname: | GR.C4 PICASSO |

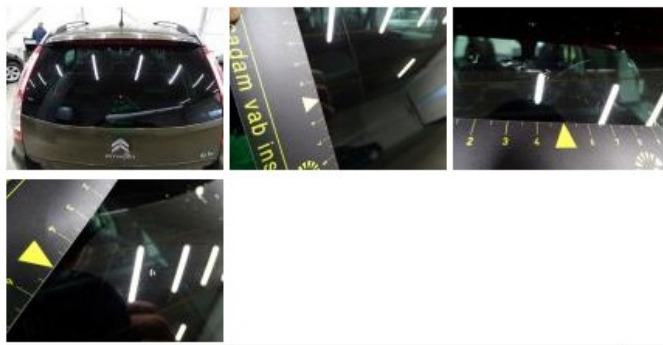
| Rear window, Scratch(es), E - Replace | 370,00 |

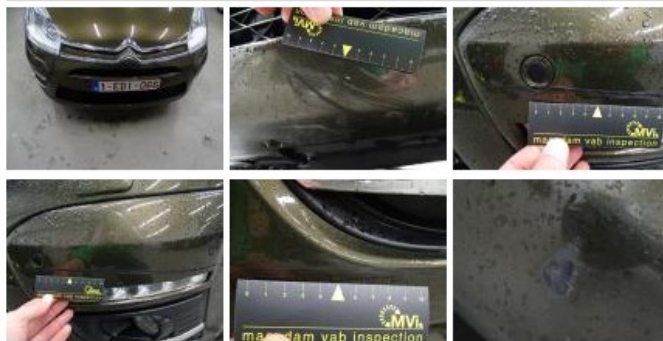
| Front bumper, Scratch(es), LI - Repair and paint (complete) | 211,80 |

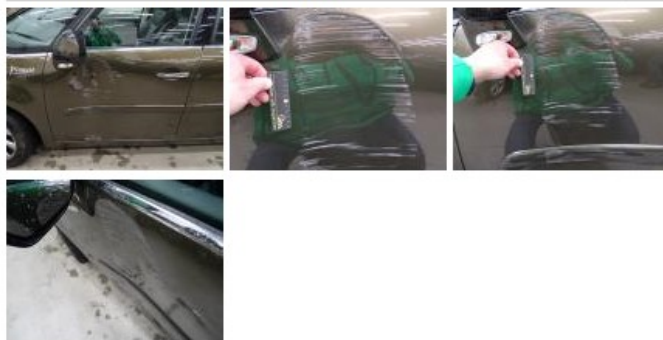
| Door F L, Accident, Le - Replace and paint | 1082,52 |

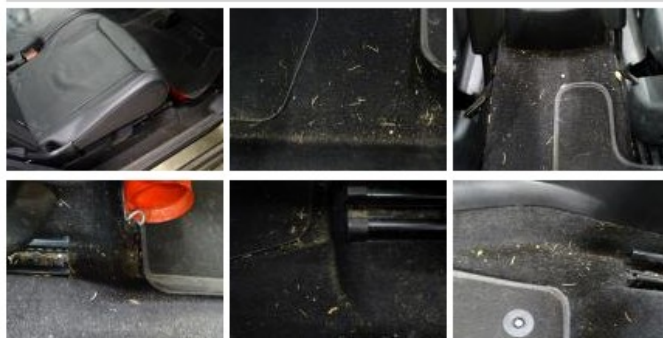
| Interior, Dirty, Cleaning | 75,00 |

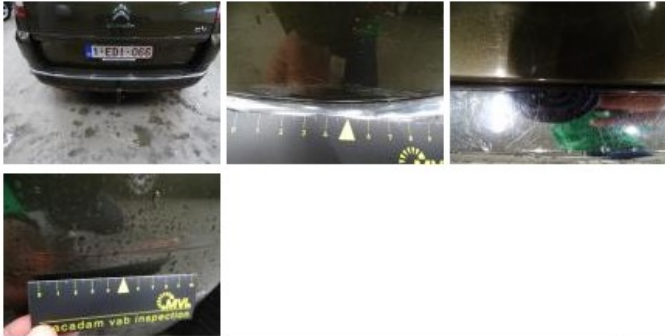
| Bumper R, Scratch(es), LI - Repair and paint (complete) | 211,80 |
