**BMW 1 HATCH: 1LEH877**

**Limited Technical Inspection**

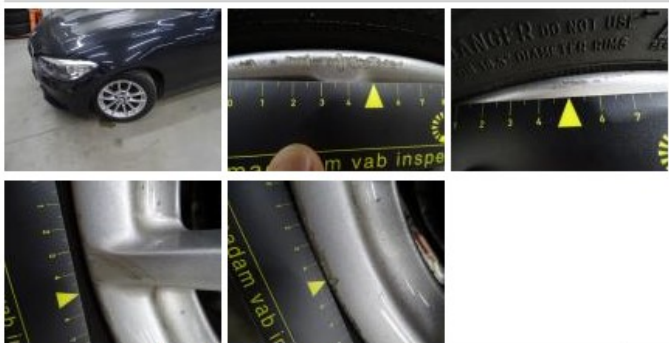
| Alloy rim F L, Scratch(es), LI - Repair and paint (complete) | | | <b>95,00</b> |
