| VOLVO V70: 1EPG417 | | | |
| Vinnnumber: | <b>YV18W31A1D1270065</b> | Versionname: | <b>V70 D3 Kinetic St/St 136PK</b> |

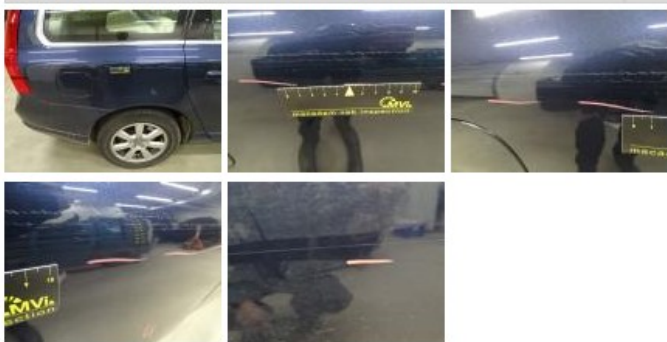
| Assistance equipment | | | |
|---|---|---|---|
| Wing R R, Scratch(es), LI - Repair and paint (complete) | | | <b>0,00</b> |

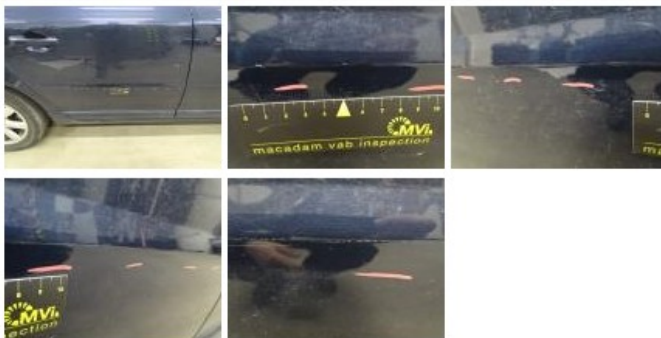
| Door R R, Scratch(es), LI - Repair and paint (complete) | 382,02 |

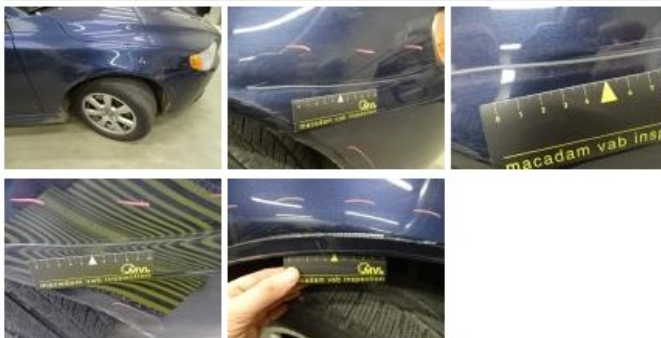
| Wing F R, Bump(s) and scratch(es), LI - Repair and paint (complete) | 264,21 |
