| Opel Astra: 1EUV541 | | | |
| Vinnnumber: | W0LPE6EW1D1071397 | Versionname: | ASTRA BER ecoFLEX Cosmo St/St 110PK |

| Limited Technical Inspection | | | |

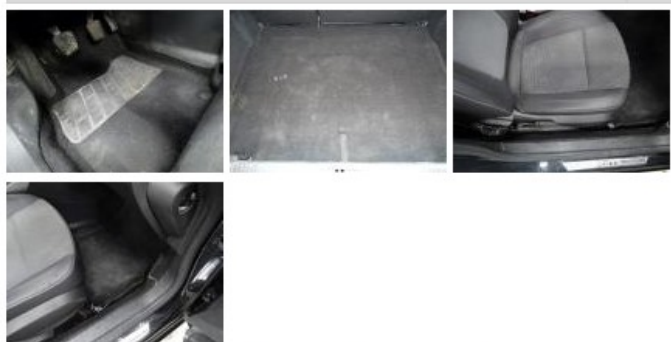
| Interior, Dirty, Cleaning | 50,00 |
