| VOLVO V70: 1FHM641 | | | |
| Vinnnumber: | <b>YV1BW88A1E1286248</b> | Versionname: | <b>V70 D4 Kinetic 163PK</b> |

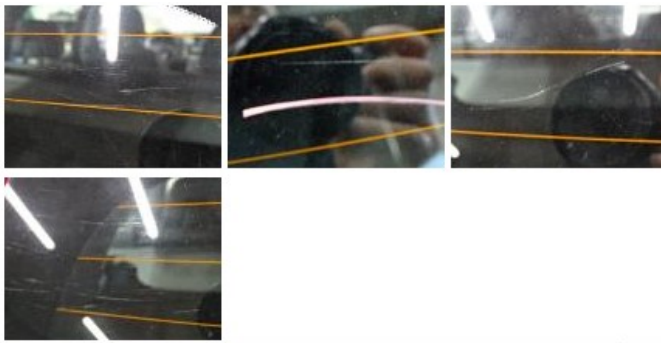
| Rear window, Scratch(es), E - Replace | <b>420,00</b> |

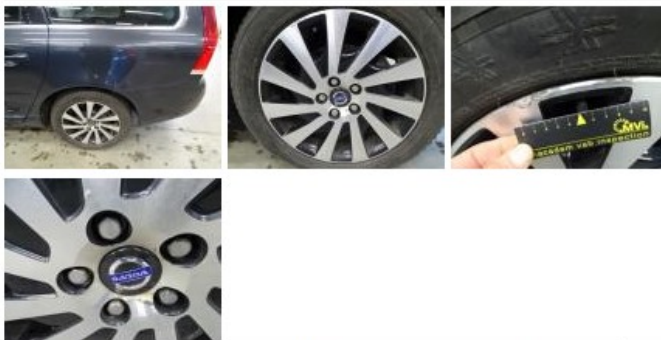
Alloy rim R L, Rust, Acceptable 0,00

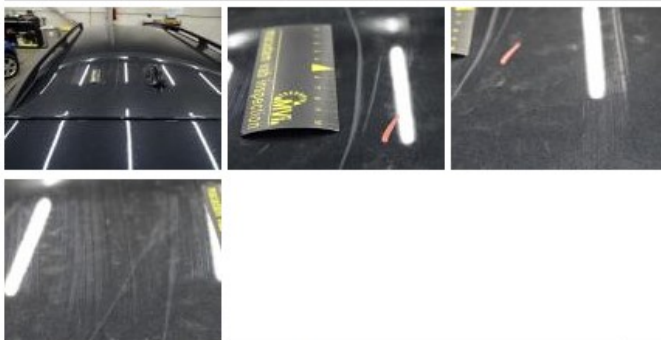
Roof, Scratch(es), LI - Repair and paint (complete) 577,80
