| VOLVO V40: 1E00198 | | | |
| Vinnnumber: | <b>YV1MV8481D2038924</b> | Versionname: | <b>V40 D2 Base 115PK</b> |

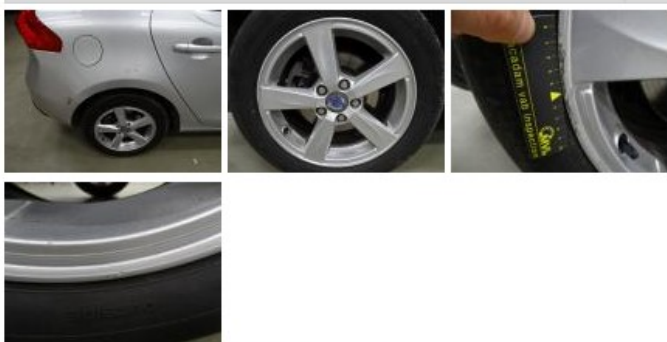
| Assistance equipment | | | |
|---|---|---|---|
| Alloy rim R R, Scratch(es), LI - Repair and paint (complete) | | | <b>95,00</b> |

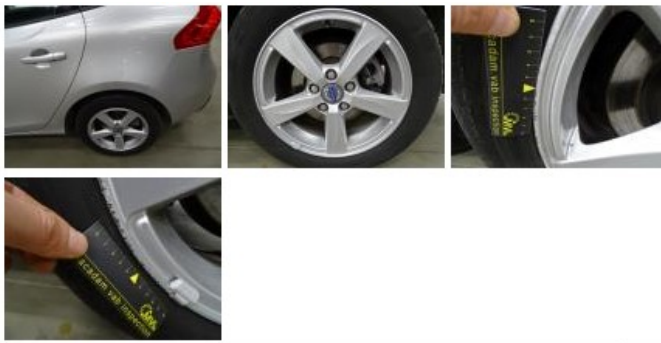
| Alloy rim R L, Scratch(es), LI - Repair and paint (complete) | <b>95,00</b> |

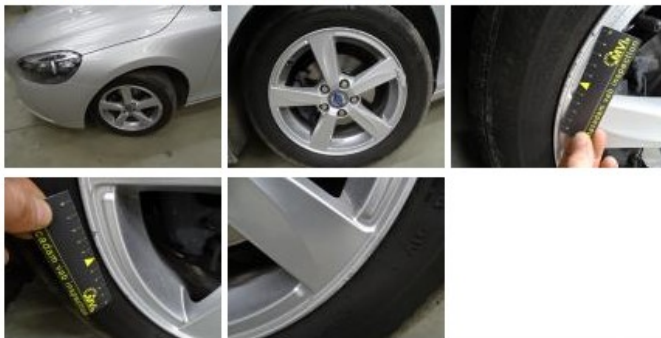
Alloy rim F L, Scratch(es), LI - Repair and paint (complete) 95,00

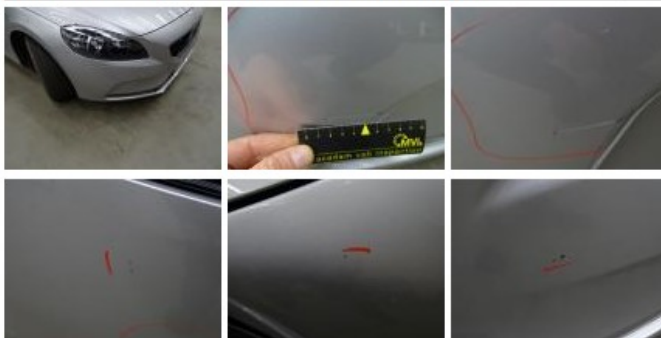
Front bumper, Scratch(es), LI - Repair and paint (complete) 211,80

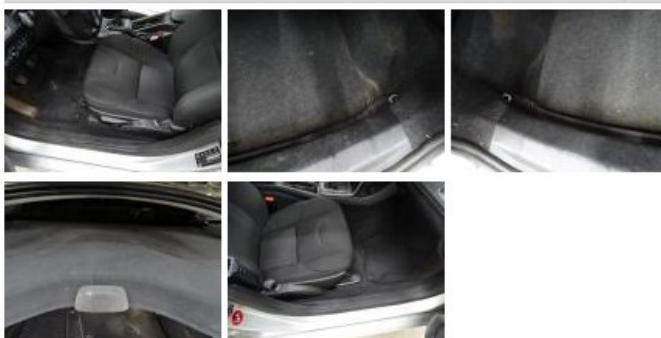
Interior, Dirty, Cleaning 100,00

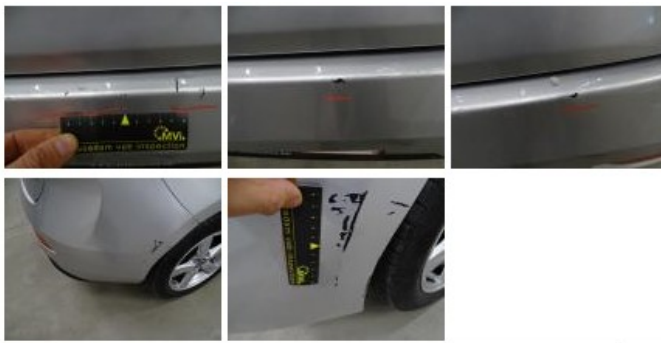
Bumper R, Scratch(es), LI - Repair and paint (complete) 211,80

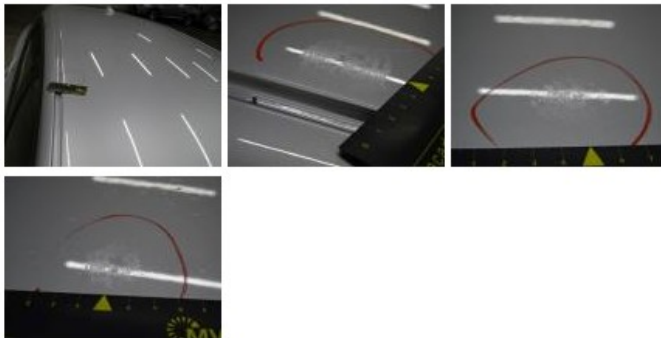
| Roof, Chemical pollution, LI - Repair and paint (complete) | 481,50 |
