| VOLVO V40: 1ERW877 | | | |
| Vinnnumber: | <b>YV1MV8481D2045730</b> | Versionname: | <b>V40 D2 Base 115PK</b> |

| Limited Technical Inspection | | | |

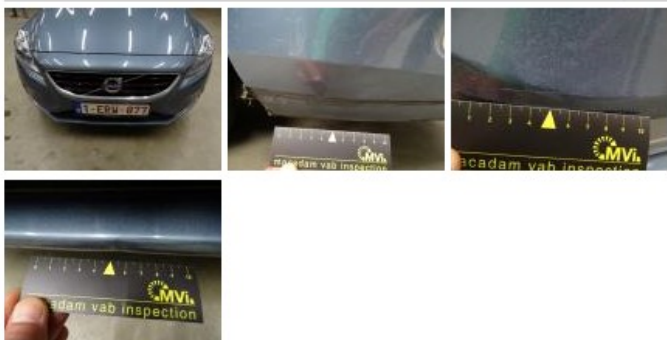
| Bonnet, Chemical polution, LI - Repair and paint (complete) | <b>290,08</b> |

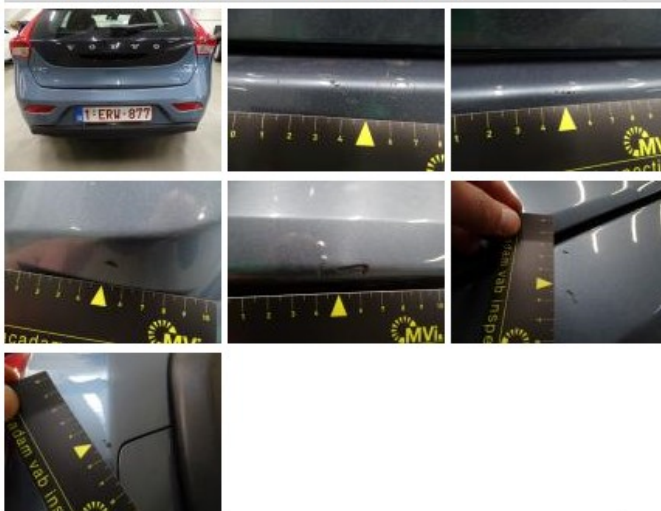
| Bumper R, Scratch(es), LI - Repair and paint (complete) | 211,80 |

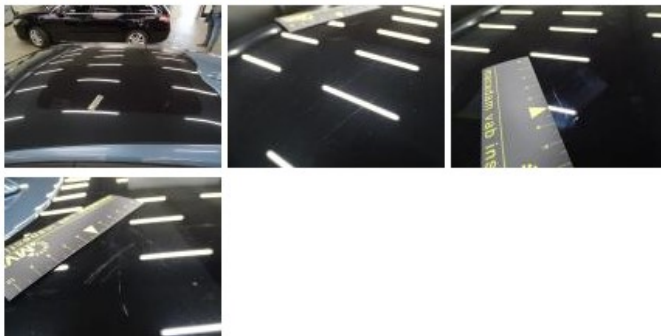
| Panoramic roof, Scratch(es), E - Replace | 0,00 |
