VOLVO V40: 1FAM158			
Vinnnumber:	YV1MV8481D2058901	Versionname:	V40 D2 Base 115PK
First Registrationdate:	7/05/2013	Fiscalpower:	
Expertise Mileage:	184517	Power Kw:	84
Bodytype:		Body color:	White
Gearbox:	MAN 6 VIT	Paint type:	Opaque
Transmission:	Front	Rims summer:	Aluminium
Fueltype:	Diesel	Oil level:	OK
Battery functioning:	Yes	Parking lot:	3116
Number of doors:	5		
Number of seats:	5		
Number head rests:	5		
Rims summer:	Aluminium		
Category:	Passenger Car		
Oil level:	OK

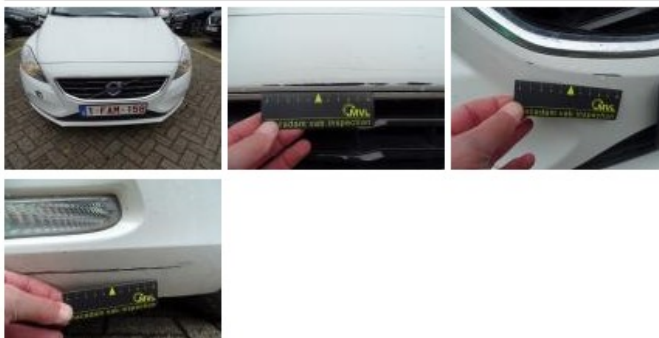
Front bumper, Scratch(es), LI - Repair and paint (complete) 211,80

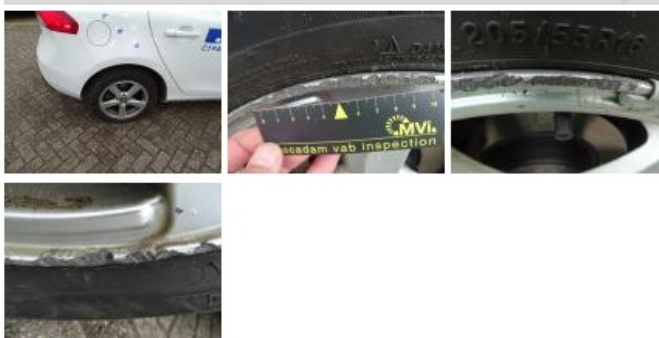
Alloy rim R R, Damaged, E - Replace 235,20
