**LU Skoda Superb Combi: VU8883**

| Vinnnumber: | <b>TMBLJ9NP2G7078740</b> | Versionname: | <b>2.0 TDI CR 140KW L&amp;K</b> |

**Limited Technical Inspection**

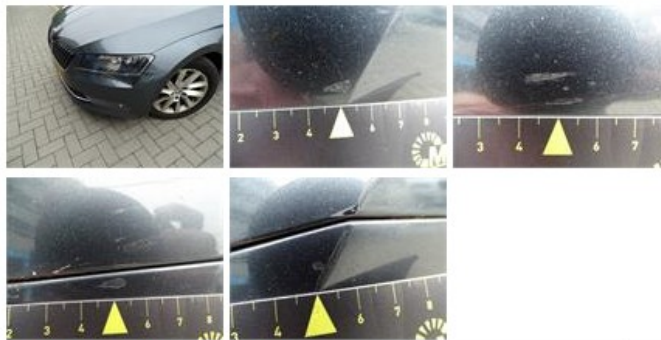
| Bumper F L, Scratch(es), It - Spot repair | 115,56 |

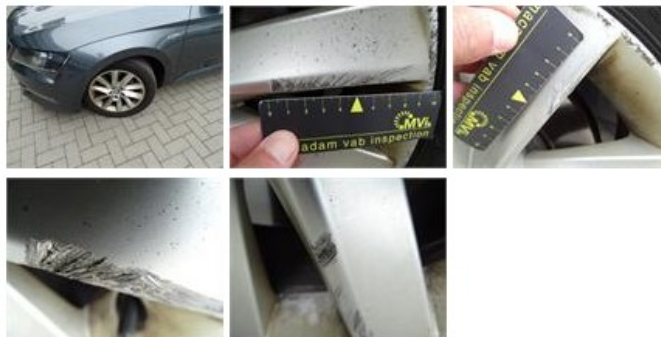
| Alloy rim F L, Damaged, E - Replace | 277,44 |
