| MERCEDES A: 1GDG452 | | | |
| Vinnnumber: | WDD1760121J229714 | Versionname: | A 180 CDI BE 109PK |

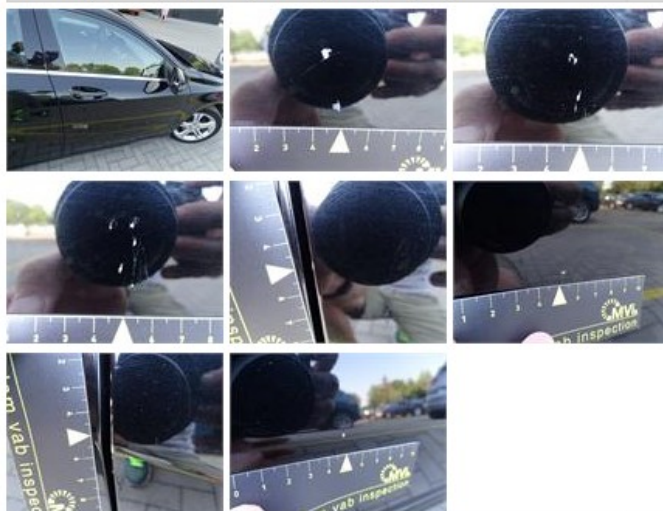
Door F R, Scratch(es), LI - Repair and paint (complete) 318,35
