| VOLKSWAGEN Caddy: 1GQV632 | | | |
| Vinnnumber: | <b>WV1ZZZ2KZEX121383</b> | Versionname: | <b>CADDY VAN BlueMotion</b> |

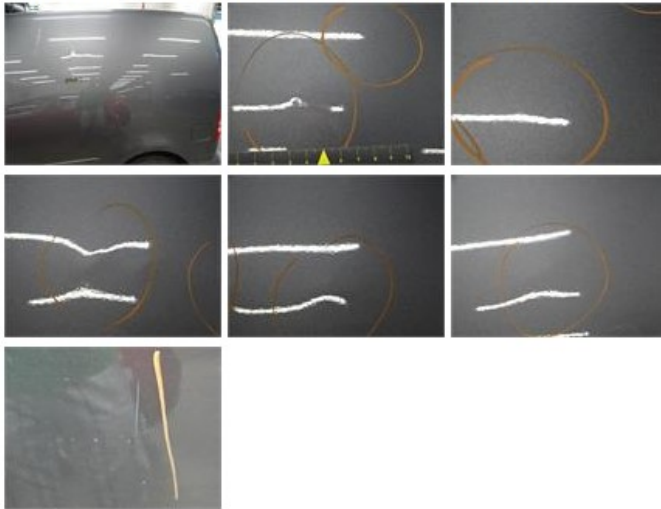
Wing R L, Bump(s) and scratch(es), LI - Repair and paint (complete) 231,15

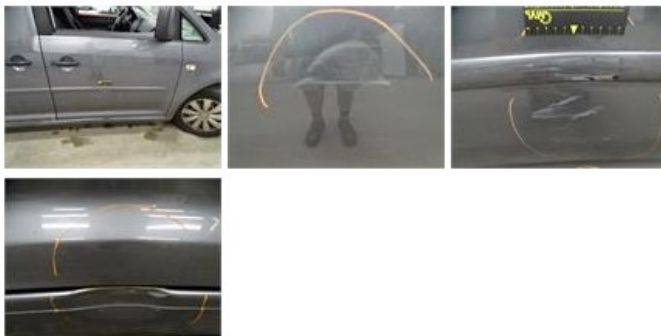
Door F R, Bump(s) and scratch(es), LI - Repair and paint (complete) 238,76

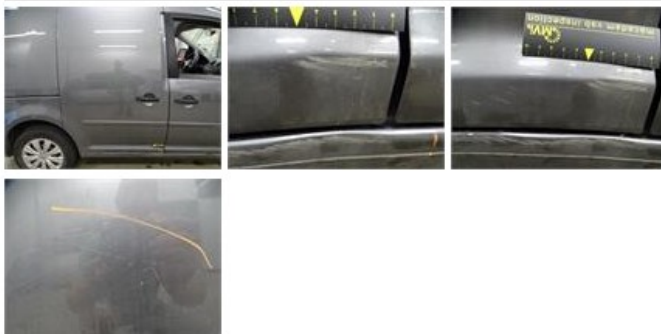
Door R R, Bump(s) and scratch(es), LI - Repair and paint (complete) 238,76
