**BMW 5: 1GMV150**

**Limited Technical Inspection**

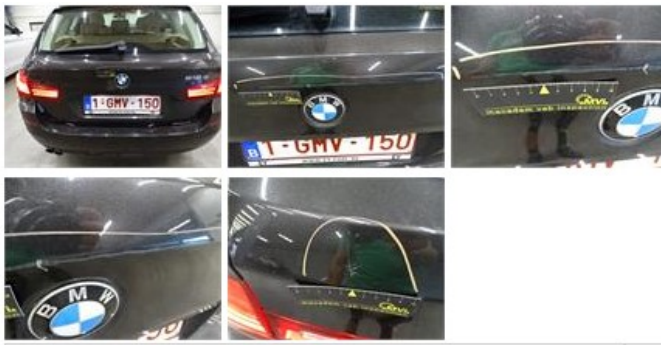
Tailgate, Scratch(es), LI - Repair and paint (complete)	362,02
---	--------

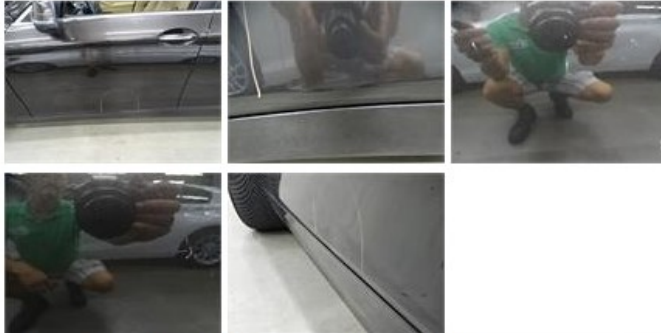
Door F L, Bump(s) and scratch(es), LI - Repair and paint (complete) 382,02

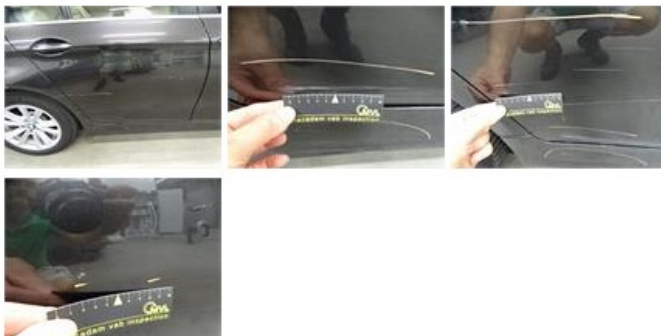
Door R R, Bump(s) and scratch(es), LI - Repair and paint (complete) 382,02

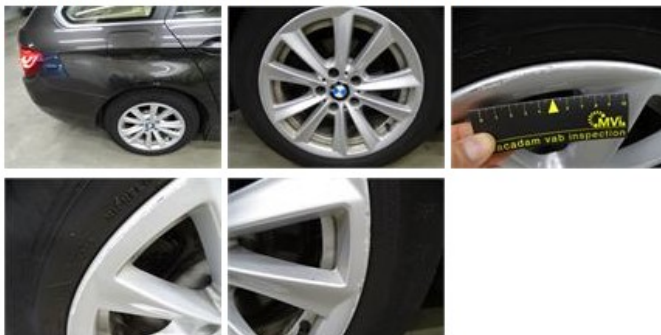
Alloy rim R R, Scratch(es), LI - Repair and paint (complete) 95,00

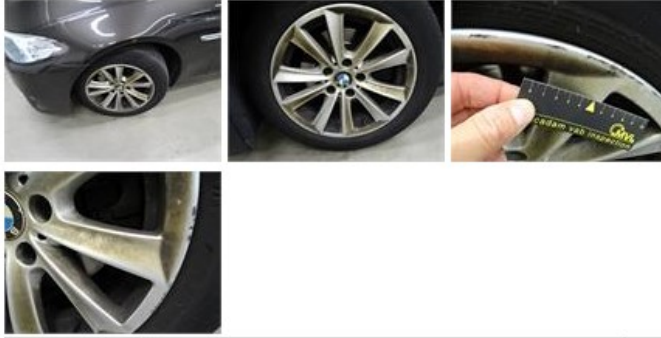
Alloy rim F L, Scratch(es), LI - Repair and paint (complete)
