| FORD S Max: 1FFR247 | | | |
| Vinnnumber: | WF0SXXGBWSD837455 | Versionname: | S-MAX Titanium DPF |

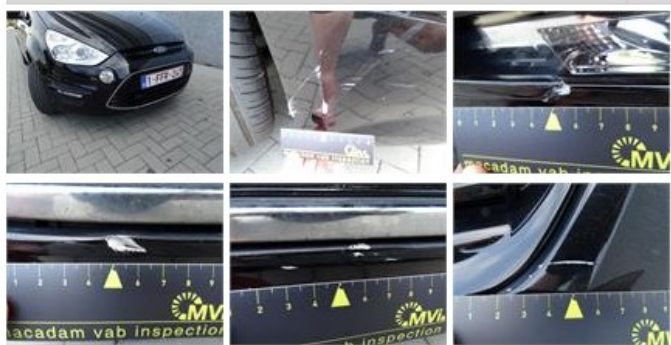
| Front bumper, Bump(s) and scratch(es), LI - Repair and paint (complete) | 254,16 |
