**VOLVO V60: 1HFA971**

| Vinnnumber: | <b>YV1FW8481E1209014</b> | Versionname: | <b>V60 BRE D2 Kinetic 115PK</b> |

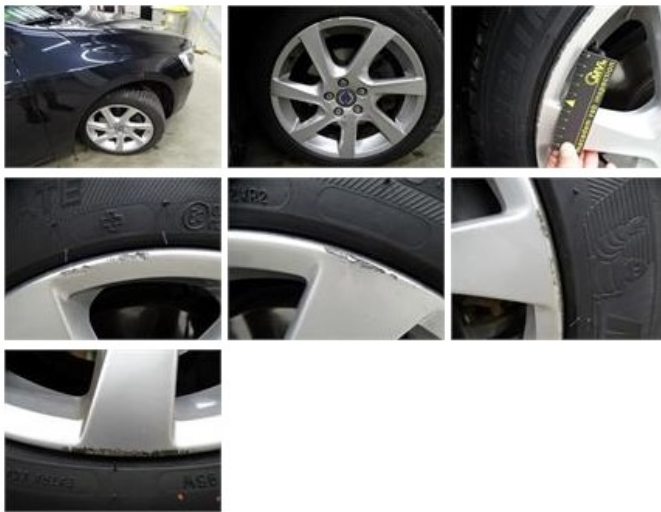
Alloy rim F R, Scratch(es), LI - Repair and paint (complete) 95,00

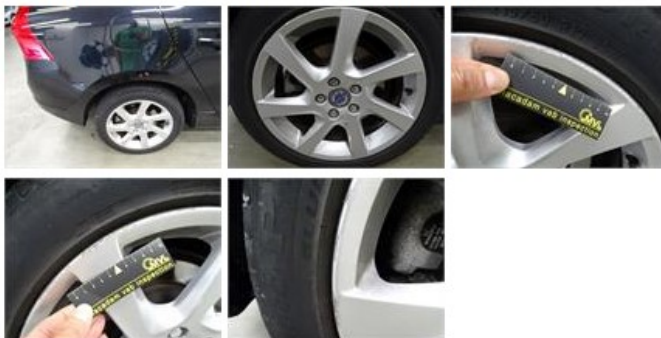
Alloy rim R R, Scratch(es), LI - Repair and paint (complete) 95,00

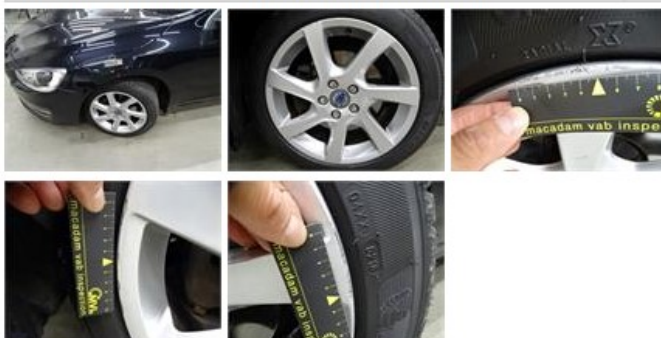
Alloy rim F L, Scratch(es), LI - Repair and paint (complete) 95,00

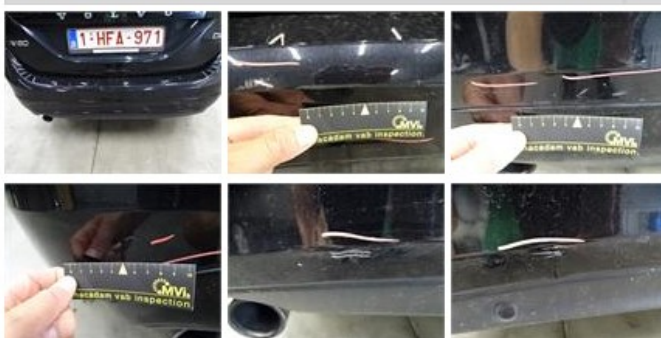
Bumper R, Dent(s) and scratch(es), LI - Repair and paint (complete) 211,80
