VOLKSWAGEN Golf: 1ESH216

| Vinnnumber: | WVWZZZAUZDW089328 | Versionname: | GOLF BER Trendline 105PK |

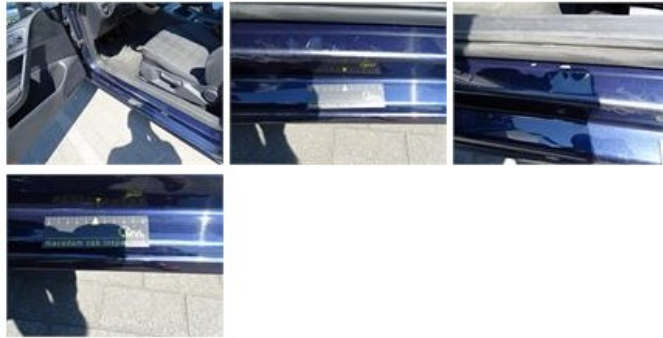
| Rocker panel inner F L, Scratch(es), LI - Repair and paint (complete) | 115,56 |

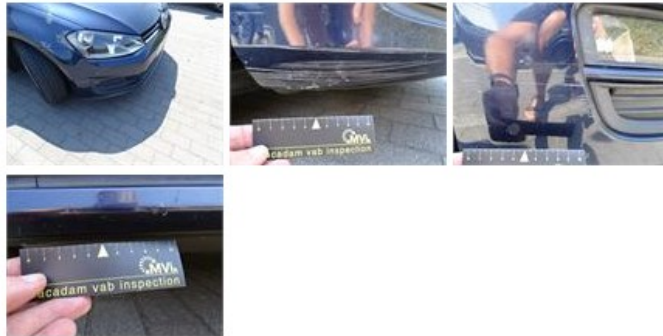
| Bumper F, Scratch(es), LI - Repair and paint (complete) | 211,80 |

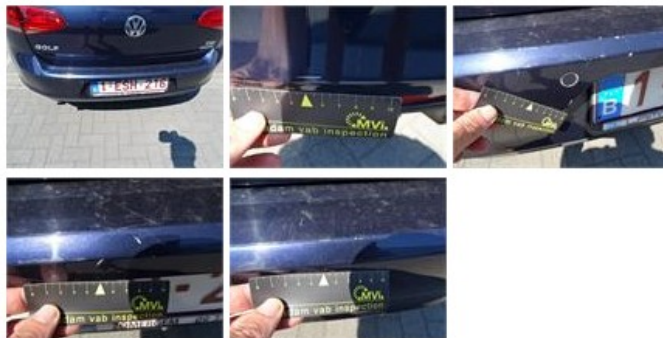
| Bumper R, Scratch(es), LI - Repair and paint (complete) | 211,80 |
