**VOLVO V40: 1GCV815**

| Vinnnumber: | <b>YV1MV8481E2125109</b> | Versionname: | <b>V40 D2 Base 115PK</b> |

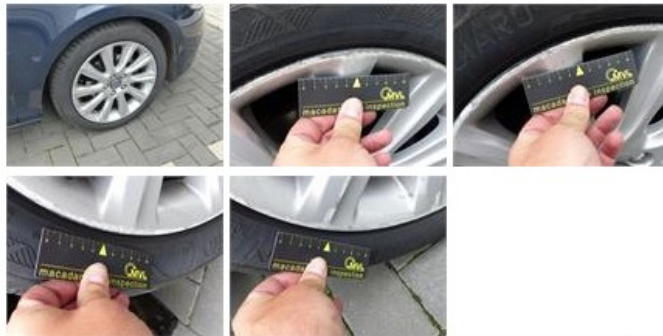
Alloy rim R L, Scratch(es), LI - Repair and paint (complete)

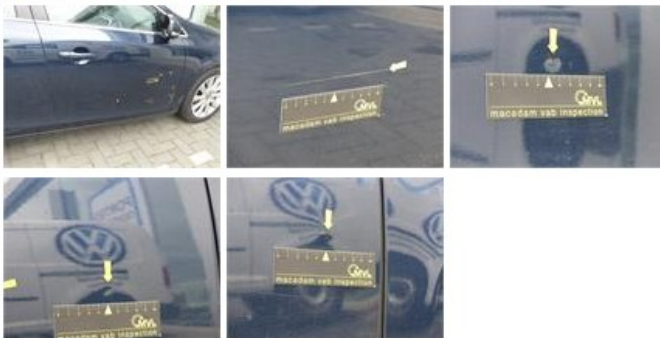
| Door F L, Chemical polution, LI - Repair and paint (complete) | 318,35 |
