| MERCEDES Sprinter 300: 235AMJ | | | |
| Vinnnumber: | WDB9062331N418213 | Versionname: | SPRINTER CH2C 311 |
| First Registrationdate: | 29/04/2009 | Fiscalpower: | 3500kg MWB 109PK |

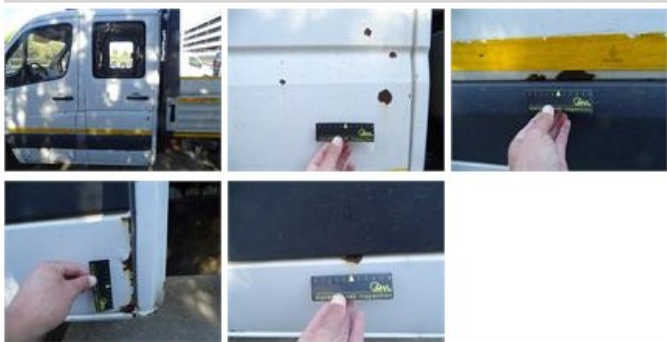
| Assistance equipment | | | |
|---|---|---|---|
| Door R L, Rust, LI - Repair and paint (complete) | | | 238,76 |
