**BMW 3: 1HHL035**

**Limited Technical Inspection**

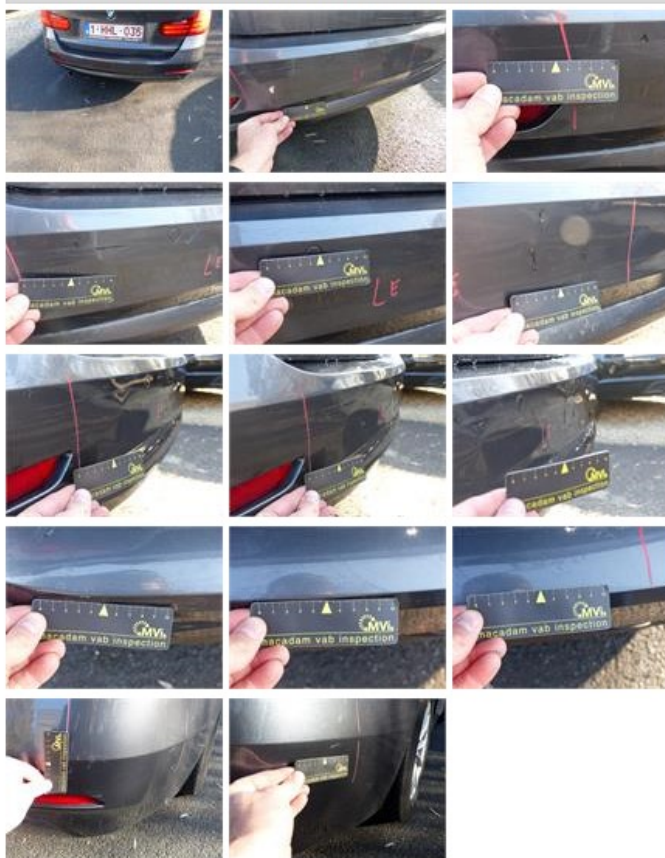
| Bumper R, Dent(s) and scratch(es), Le - Replace and paint | | 651,00 |

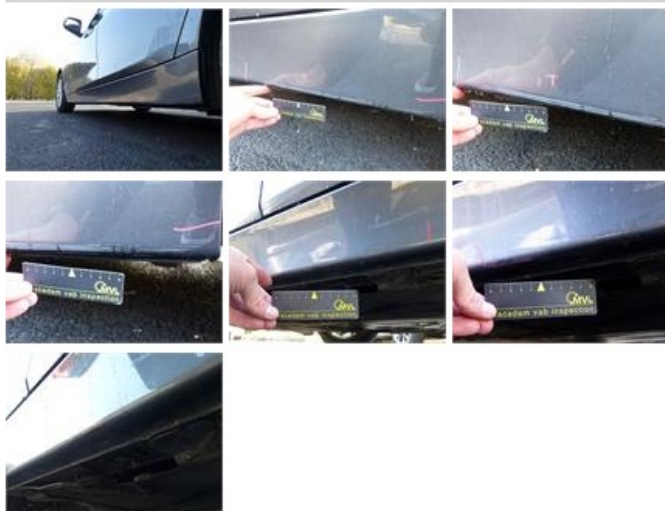
| Sill trim L, Scratch(es), It - Spot repair | | 115,56 |
