**SKODA Superb: 1HXL457**

**Limited Technical Inspection**

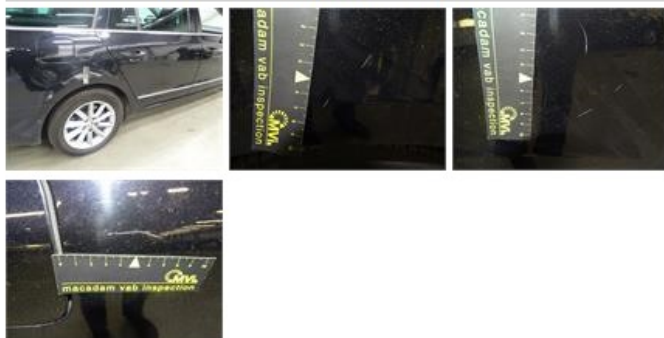
| Wing R R, Scratch(es), LI - Repair and paint (complete) | 369,84 |
