# BMW 1 HATCH: 1LHL605

| Vinnumber: | WBA1V910805B19734 | Versionname: | 1.5 116D EFFICIENTDYNAMICS EDIT. (85KW) |

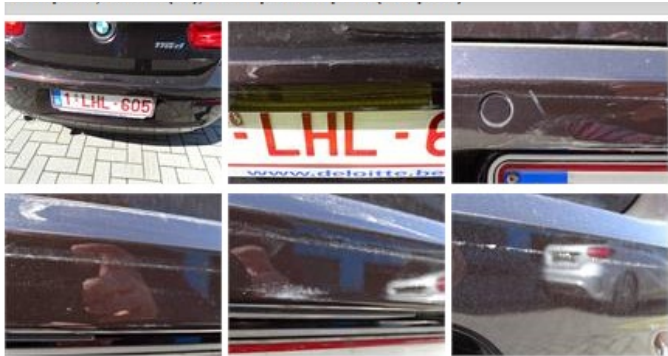
| Bumper R, Scratch(es), LI - Repair and paint (complete) | | | 169,44 |

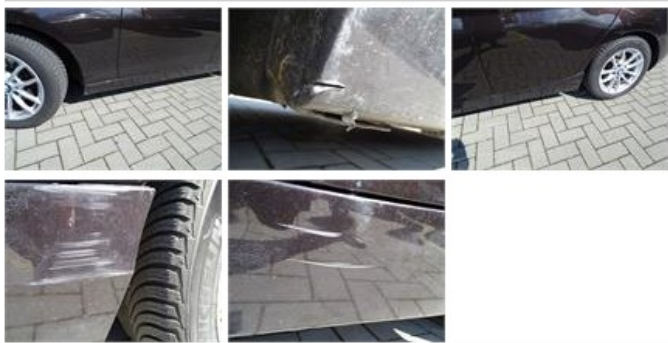
| | | Sill outer L, Crack, Le - Replace and paint | 579,20 |

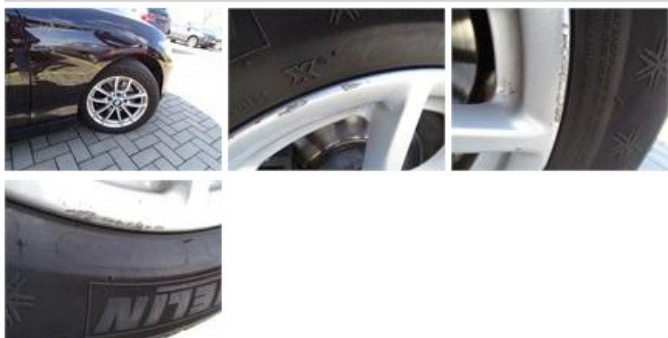
| | | Alloy rim F R, Scratch(es), LI - Repair and paint (complete) | 95,00 |
