**AUDI A6: 1GRJ636**

| Vinnumber: | <b>WAUZZZ4G6EN119574</b> | Versionname: | <b>A6 AVANT 136PK</b> |

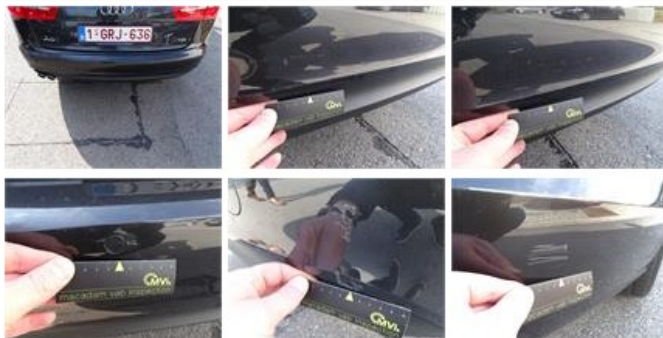
Bumper R, Scratch(es), LI - Repair and paint (complete)

254,16
