**BMW 2 Active Tourer: 1JFJ391**

**Limited Technical Inspection**

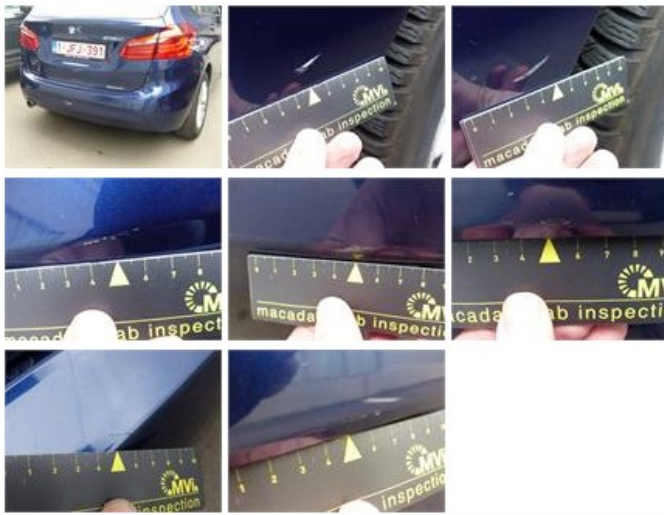
| Bumper R, Scratch(es), LI - Repair and paint (complete) | | <b>211,80</b> |

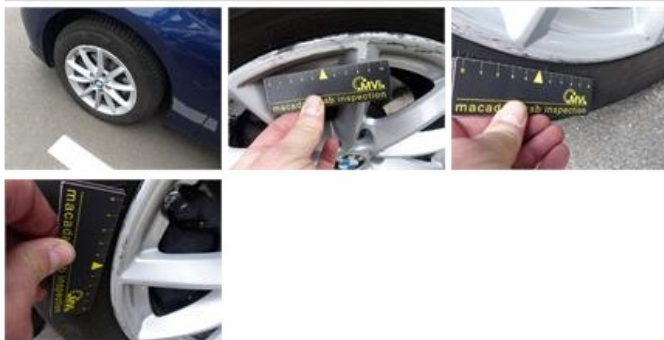
| Alloy rim F L, Scratch(es), LI - Repair and paint (complete) | 95,00 |

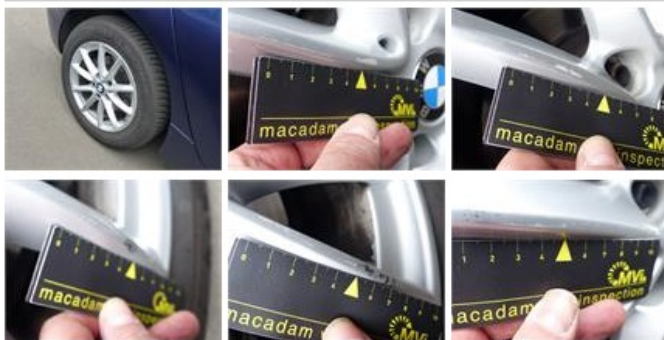
| Alloy rim R R, Scratch(es), LI - Repair and paint (complete) | 95,00 |
