**SKODA Superb: 1FUY064**

**Limited Technical Inspection**

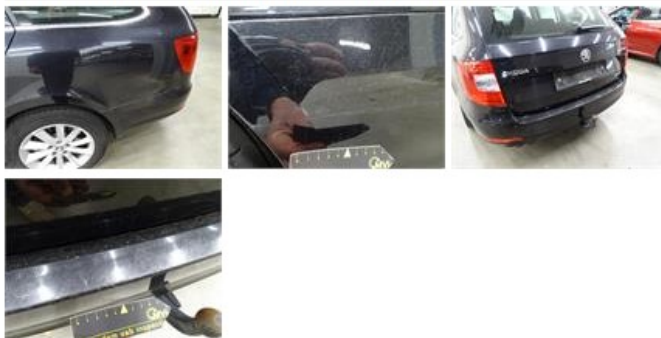
Bumper R, Scratch(es), LI - Repair and paint (complete)

211,80
