**VOLVO V40: 1RRD547**

**Limited Technical Inspection**

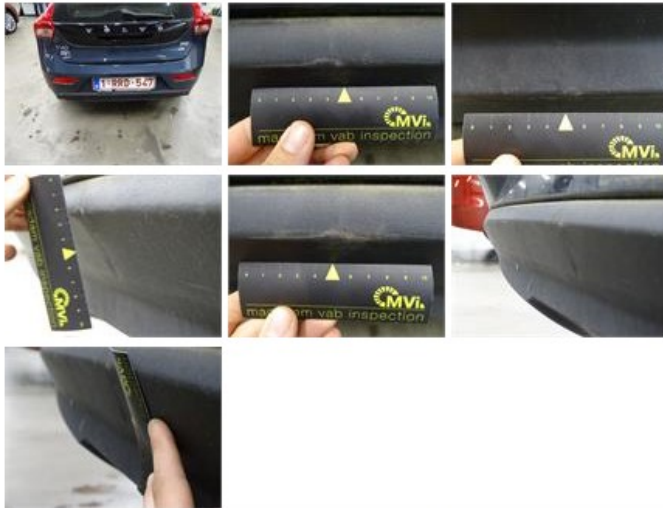
Bumper R, Dent(s) and scratch(es), Smart repair 110,64

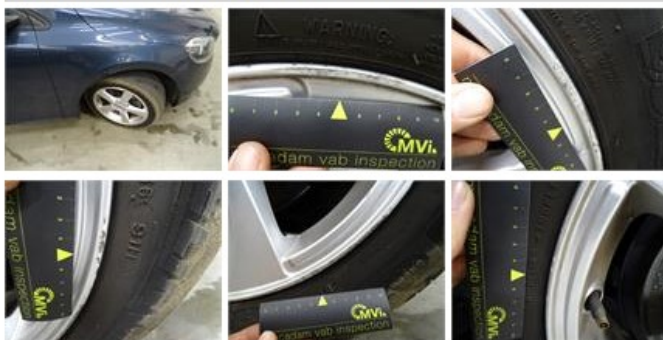
Alloy rim F R, Scratch(es), LI - Repair and paint (complete) 95,00

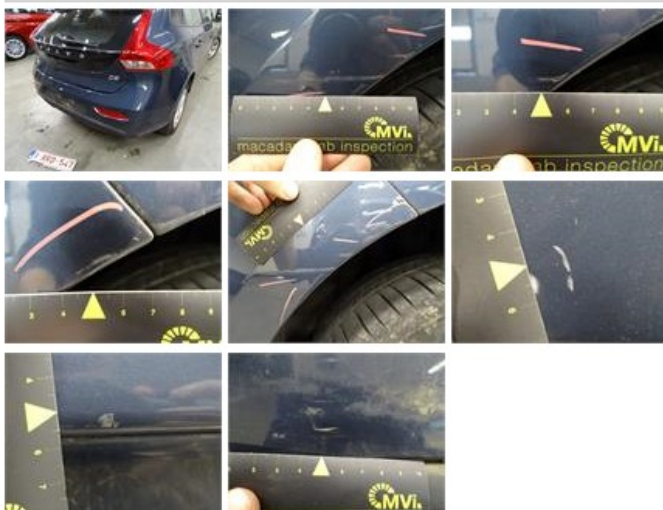
Bumper R, Scratch(es), LI - Repair and paint (complete) 211,80
