**VOLKSWAGEN Golf: 1GGS749**

| Vinnumber: | WVWZZZAUZEP549582 | Versionname: | GOLF VAR Trendline 105PK |

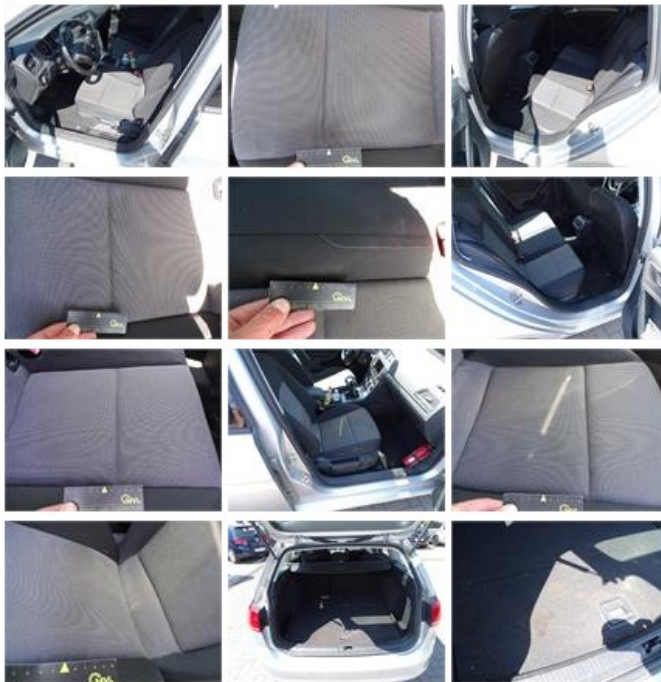
Interior, Dirty, Cleaning

125,00

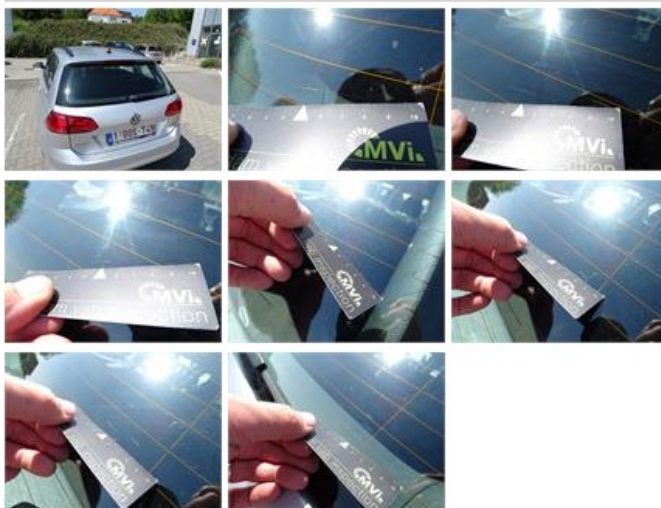
Rear window, Scratch(es), E - Replace

370,00

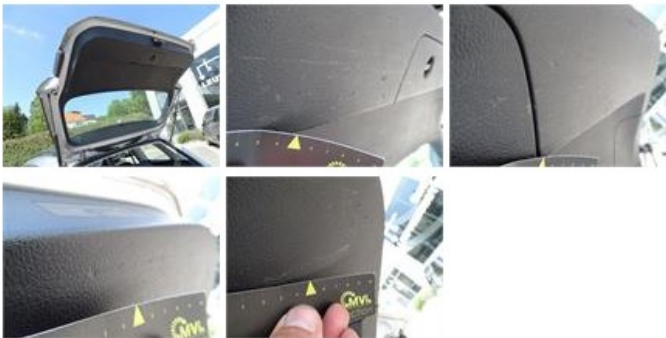
| Trunk lid covering R, Scratch(es), Smart repair | 110,64 |
