**SKODA SUPERB COMBI: 1KSV032**

| Vinnumber: | <b>TMBJJ73T5F9042877</b> | Versionname: | <b>1.6 CRTDI 77KW GREENLINE AMBITION</b> |

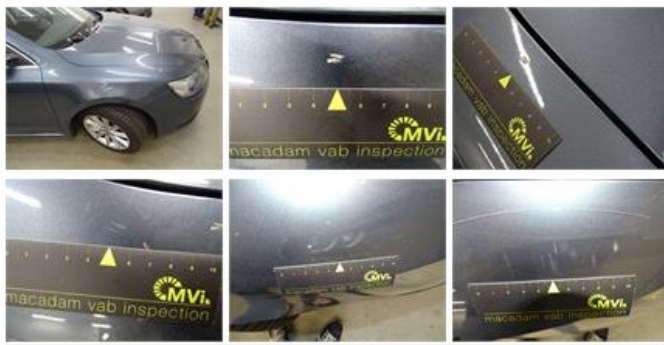
| Wing F R, Dent(s) and scratch(es), LI - Repair and paint (complete) | 264,21 |

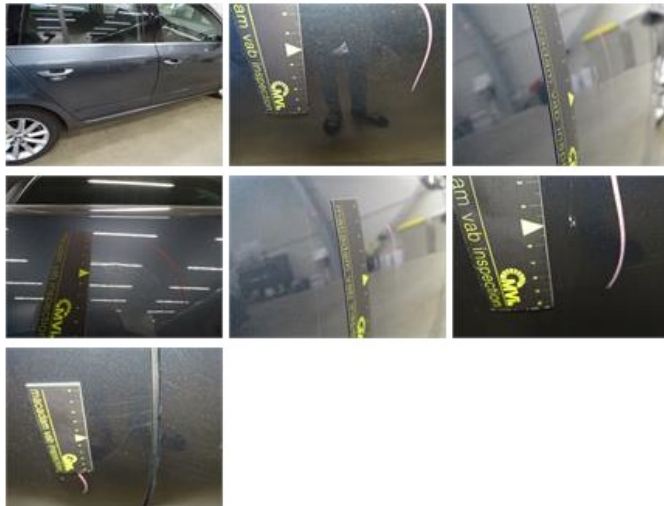
Door R R, Dent(s) and scratch(es), LI - Repair and paint (complete)

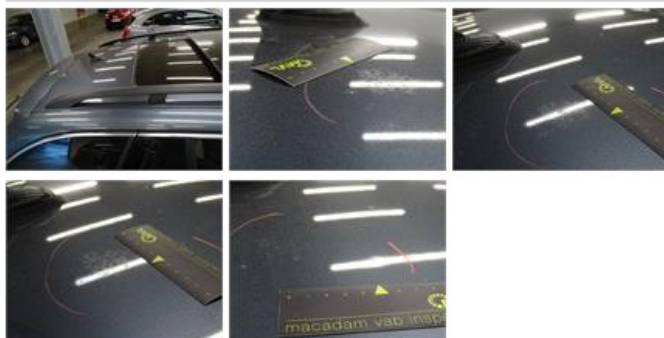
Roof, Chemical polution, LI - Repair and paint (complete)

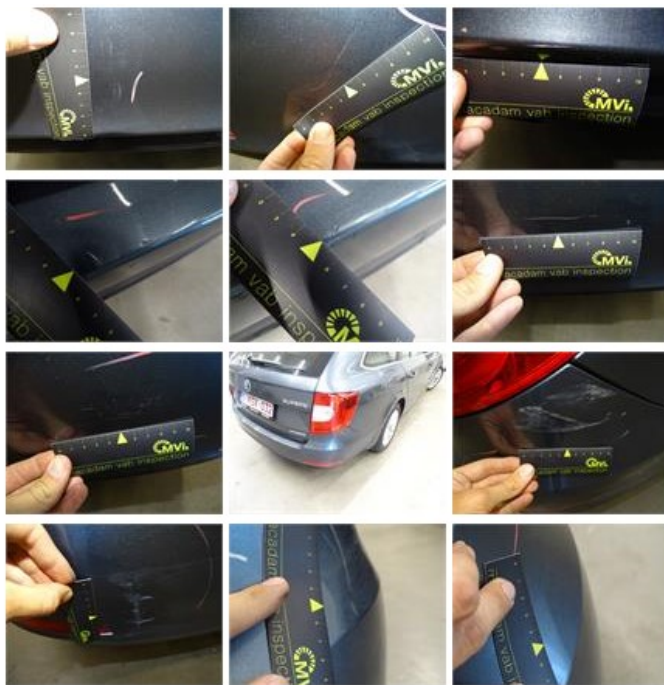
Bumper R, Dent(s) and scratch(es), LI - Repair and paint (complete)
