**BMW 1 HATCH: VJ8884**

| Vinnumber: | <b>WBA1U510505874444</b> | Versionname: | <b>2.0 118D XDRIVE (110KW)</b> |

**Limited Technical Inspection**

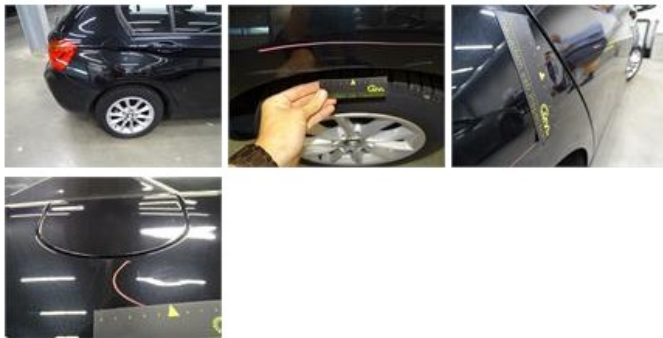
Wing R R, Dent(s) and scratch(es), LI - Repair and paint (complete)

308,20

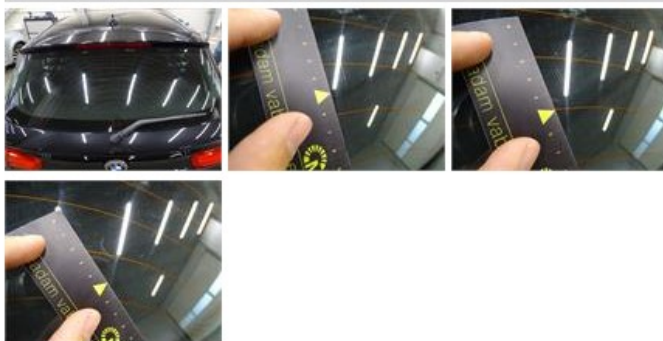
Rear window, Scratch(es), Acceptable

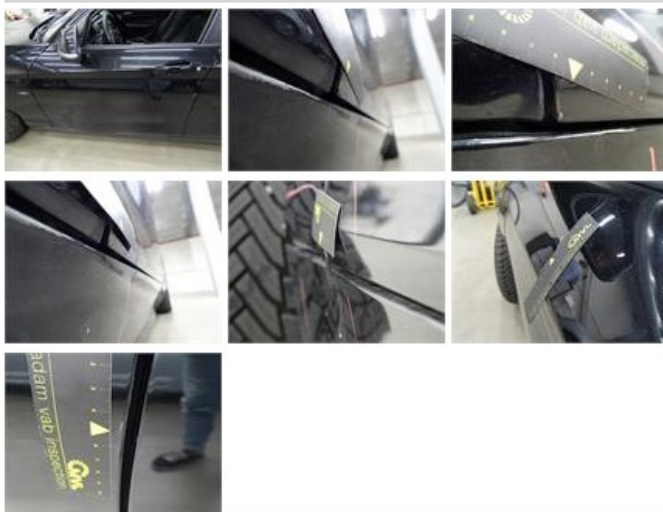
Door F L, Deformed / Strained, LI - Repair and paint (complete)

318,35

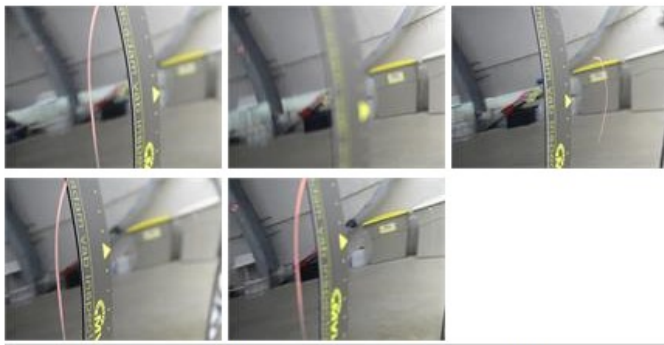
Door F R, Dent(s) and scratch(es), LI - Repair and paint (complete)

318,35

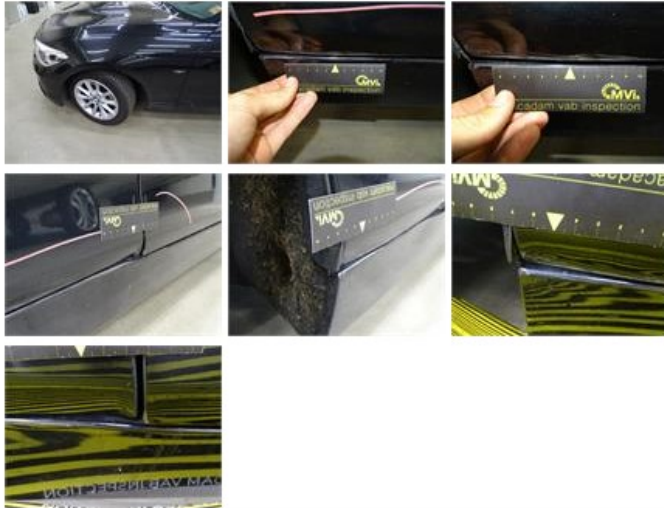
Wing F L, Dent(s) and scratch(es), LI - Repair and paint (complete)

220,18

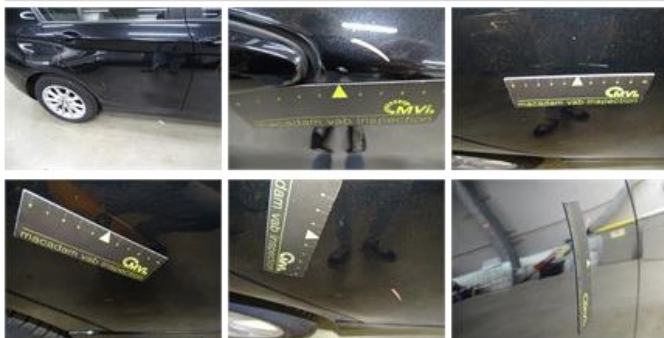
Door R R, Dent(s) and scratch(es), LI - Repair and paint (complete)

318,35

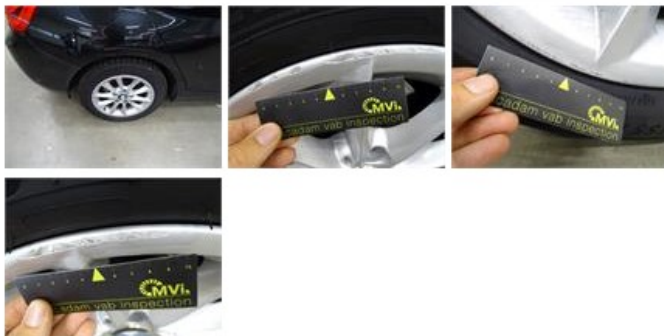
Alloy rim R R, Scratch(es), LI - Repair and paint (complete)

95,00
