VOLVO V40: 1GSY180

Limited Technical Inspection

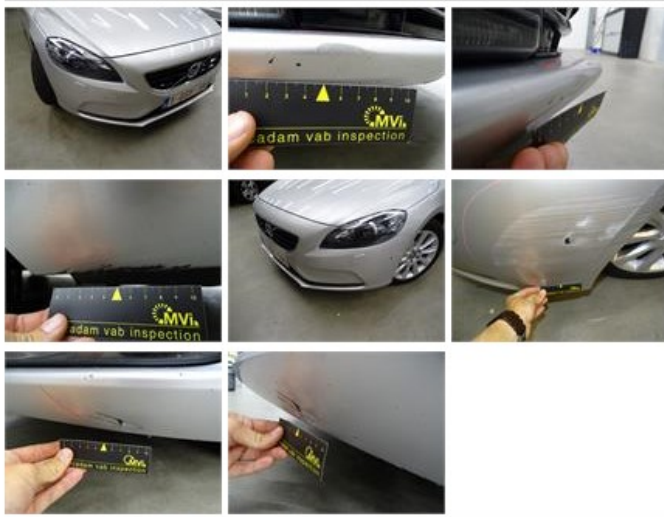
Bumper F, Dent(s) and scratch(es), LI - Repair and paint (complete) 211,80

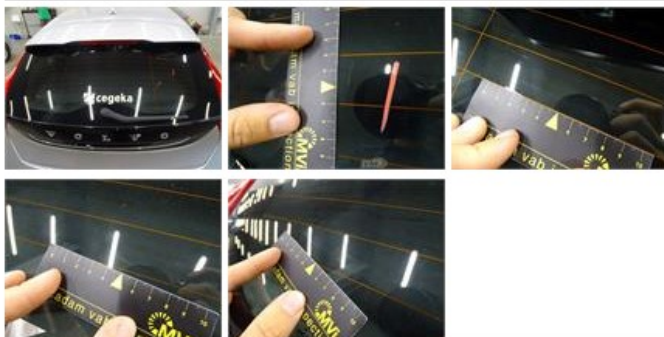
Rear window, Scratch(es), Acceptable 0,00

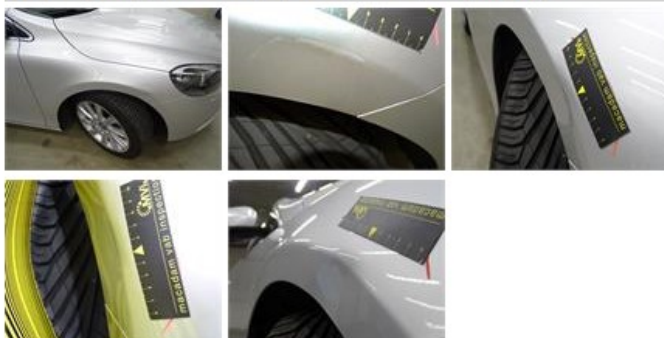
Wing F R, Dent(s) and scratch(es), LI - Repair and paint (complete) 220,18
