**AUDI A3: 1HFL609**

| Vinnumber: | <b>WAUZZZ8V5FA011514</b> | Versionname: | <b>A3 SB Ultra Attraction 110PK</b> |

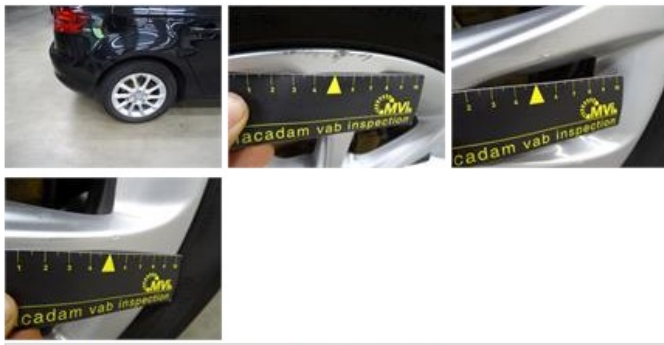
| Alloy rim R R, Scratch(es), LI - Repair and paint (complete) | 95,00 |

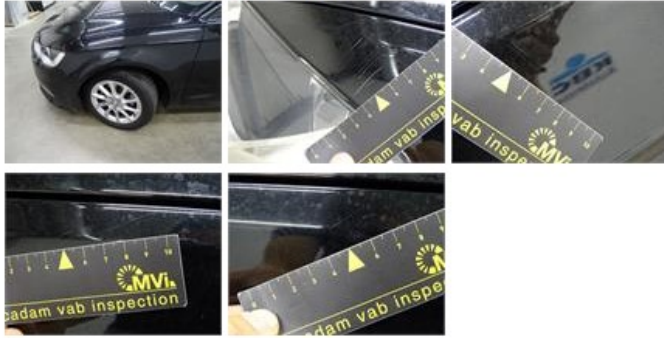
Wing F L, Scratch(es), LI - Repair and paint (complete)

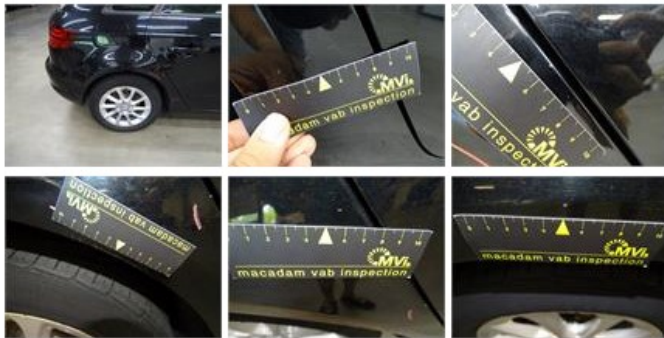
Wing R R, Scratch(es), LI - Repair and paint (complete)

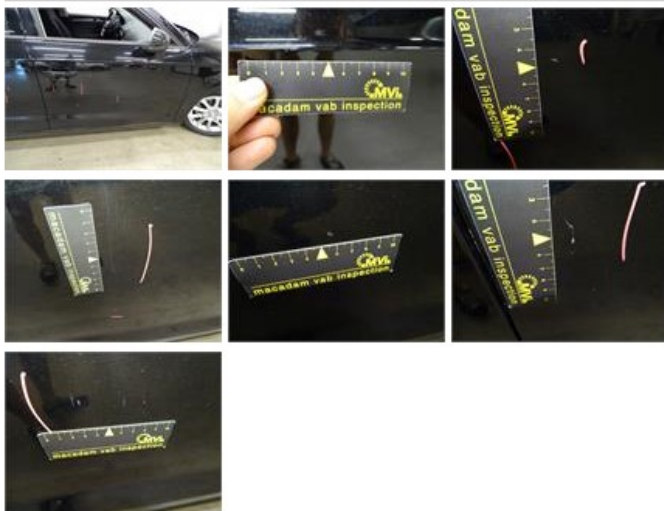
Door F R, Scratch(es), LI - Repair and paint (complete)

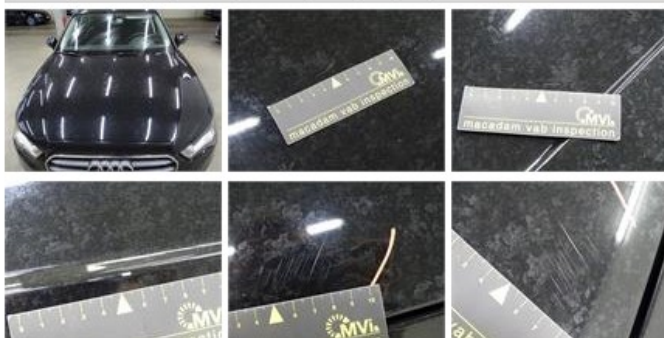
Bonnet, Scratch(es), LI - Repair and paint (complete)

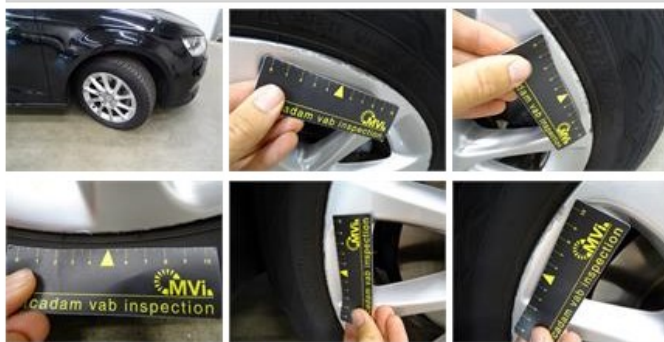
Alloy rim F L, Scratch(es), LI - Repair and paint (complete)

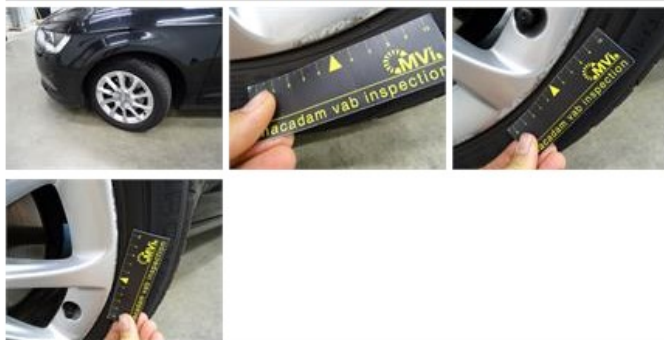
Alloy rim F L, Scratch(es), LI - Repair and paint (complete)

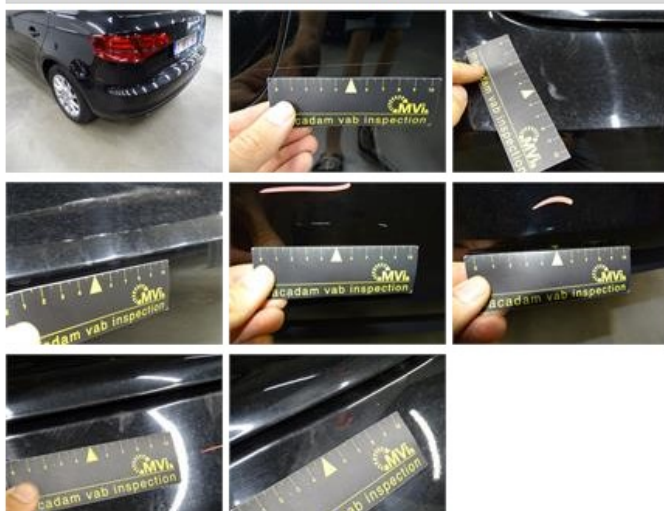
Bumper R, Scratch(es), LI - Repair and paint (complete)
