# BMW 3 TOURING: 1KHG848

| Vinnumber: | WBA3K11090F839215 | Versionname: | 2.0 318D (100KW) TOURING |

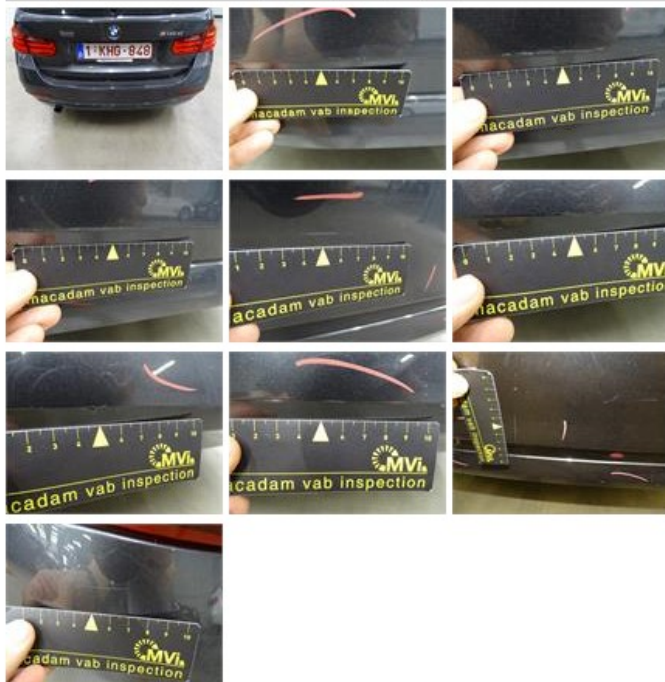
| Bumper R, Scratch(es), LI - Repair and paint (complete) | 211,80 |

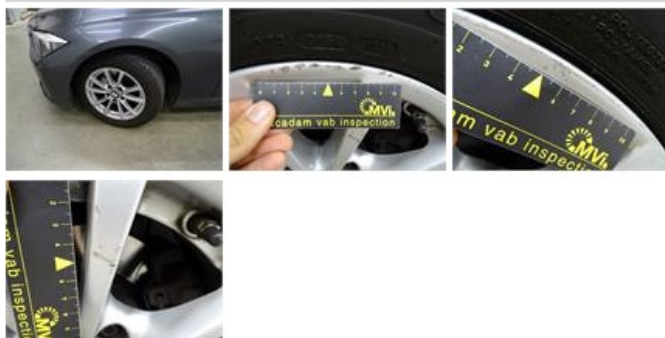
| Alloy rim F L, Scratch(es), LI - Repair and paint (complete) | 95,00 |

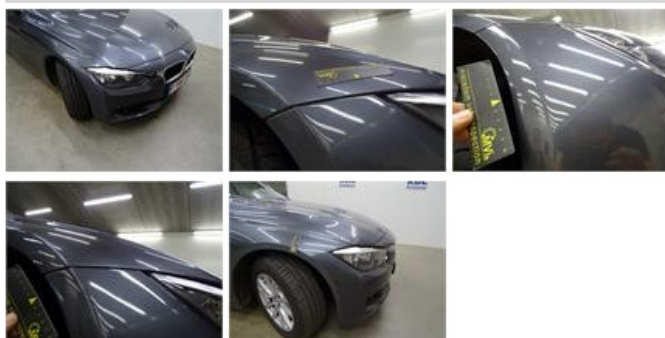
| Bumper F, Bad repair, Acceptable | 0,00 |

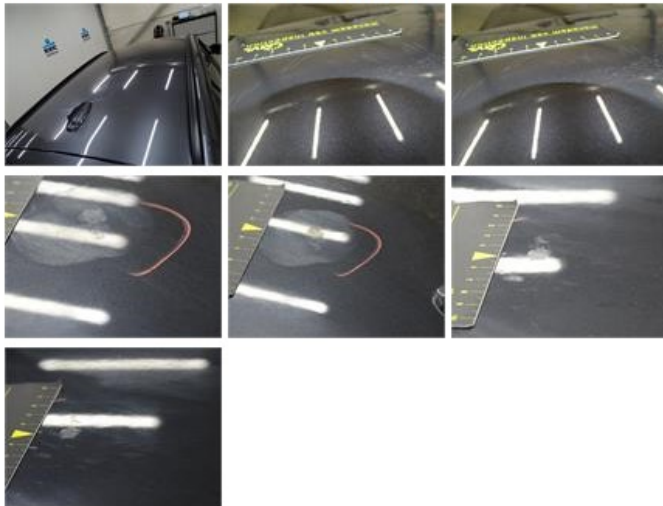
| Roof, Scratch(es), LI - Repair and paint (complete) | 0,00 |

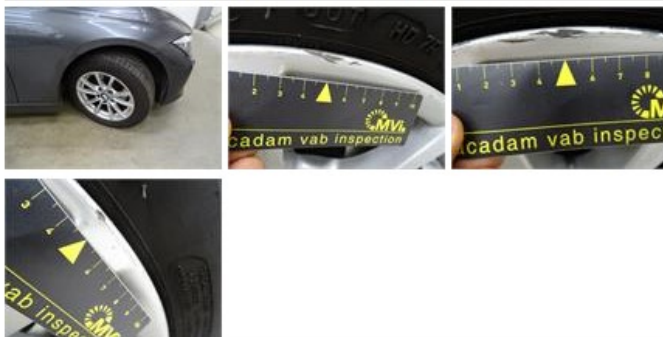
| Alloy rim F R, Scratch(es), LI - Repair and paint (complete) | 95,00 |
