# BMW 5: 1HUU481

| Vinnumber: | WBA5L11010D968745 | Versionname: | 5 TOURING 518dA 150PK Aut. |

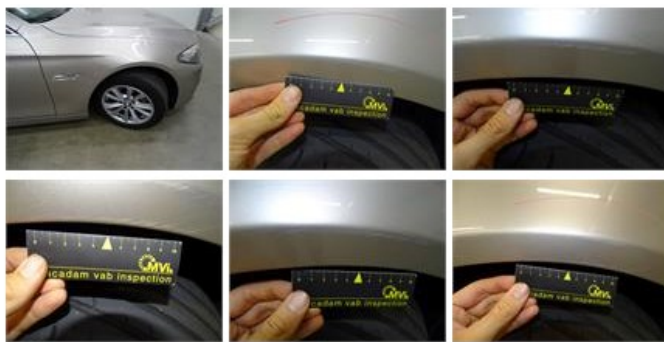
| Wing F R, Scratch(es), LI - Repair and paint (complete) | 264,21 |

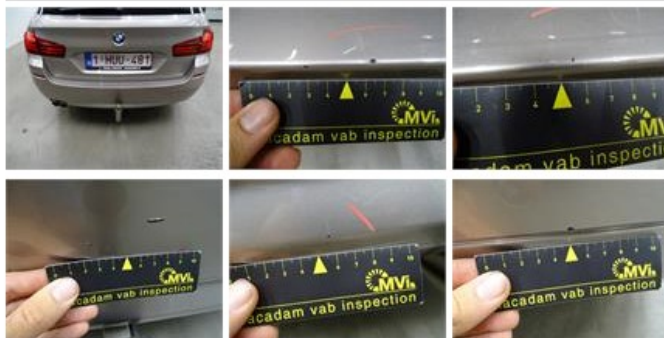
| Bumper R, Scratch(es), LI - Repair and paint (complete) | 254,16 |

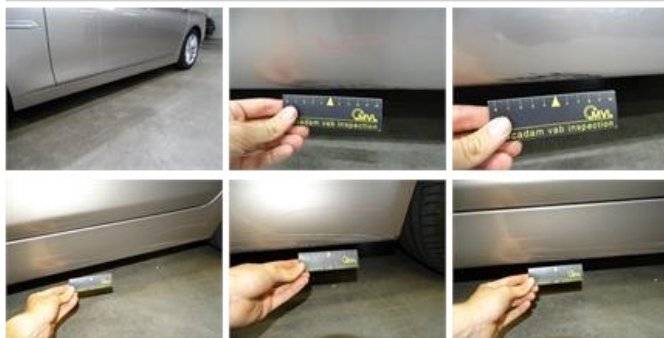
| Sill outer L, Scratch(es), LI - Repair and paint (complete) | 372,60 |
