## VOLKSWAGEN GOLF VII: 1KFF287

| Vinnumber: | WVWZZZAUZFP100502 | Versionname: | 1.6 TDI 77KW BMT TRENDLINE |

## Limited Technical Inspection

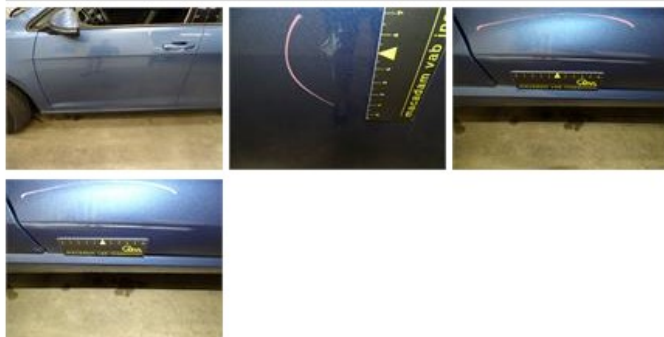
Door F L, Scratch(es), LI - Repair and paint (complete)

318,35

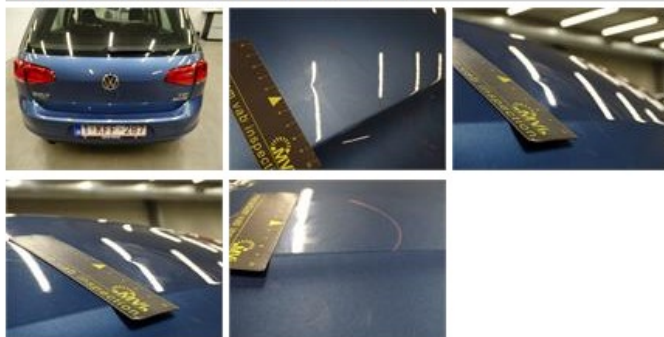
Tailgate, Dent(s), LI - Repair and paint (complete)

301,68

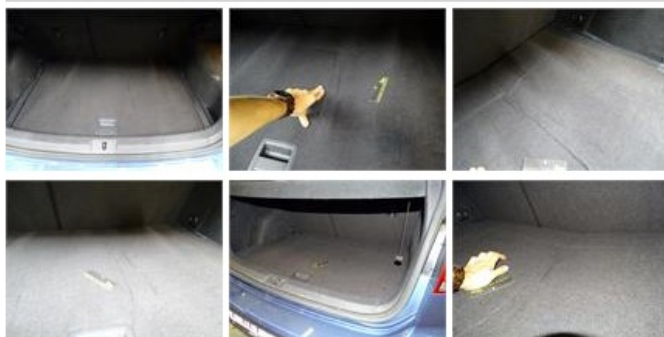
Boot carpet, Damaged, E - Replace

100,00

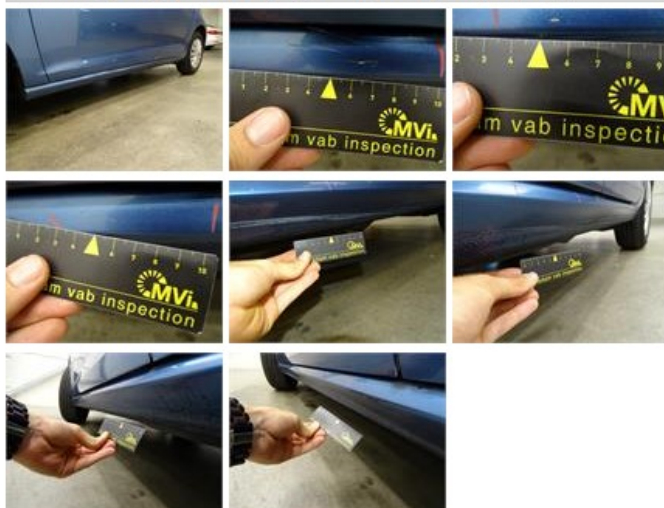
Sill outer L, Dent(s) and scratch(es), LI - Repair and paint (complete)

310,50

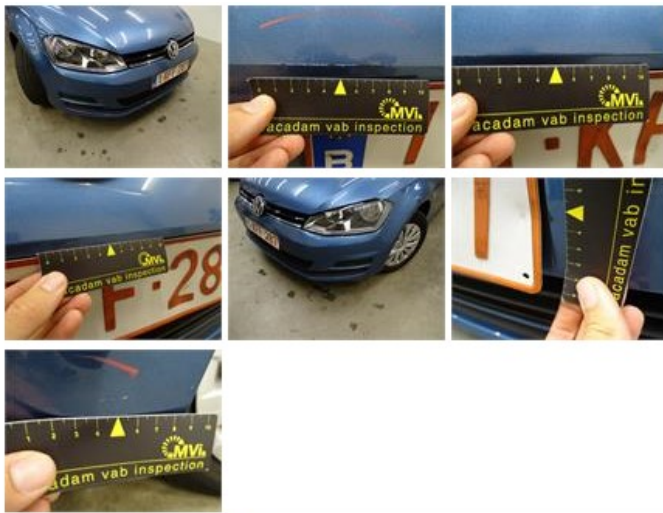
Bumper F, Scratch(es), LI - Repair and paint (complete)

211,80

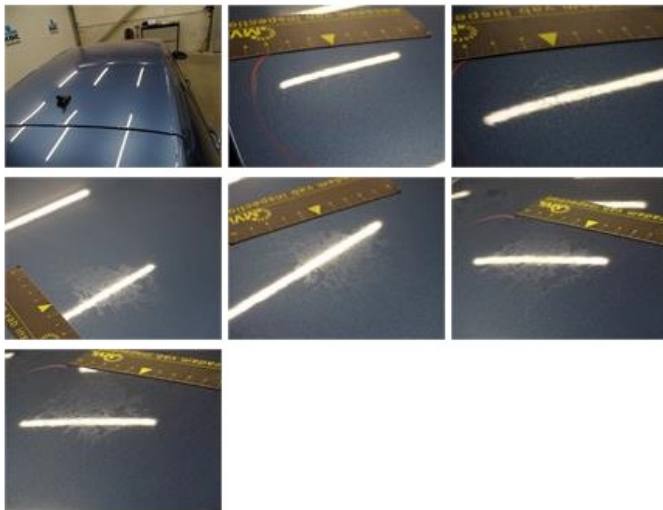
Roof, Chemical polution, LI - Repair and paint (complete)

481,50

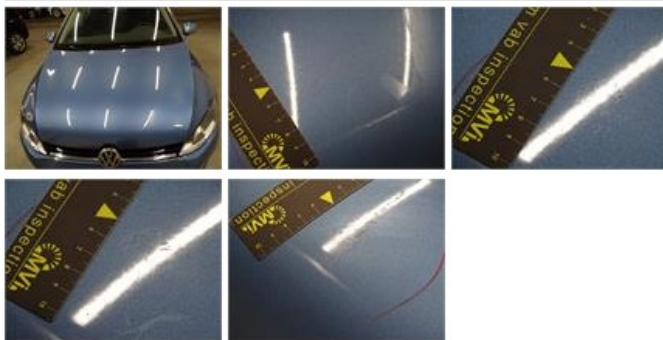
Bonnet, Chemical polution, LI - Repair and paint (complete)

290,08

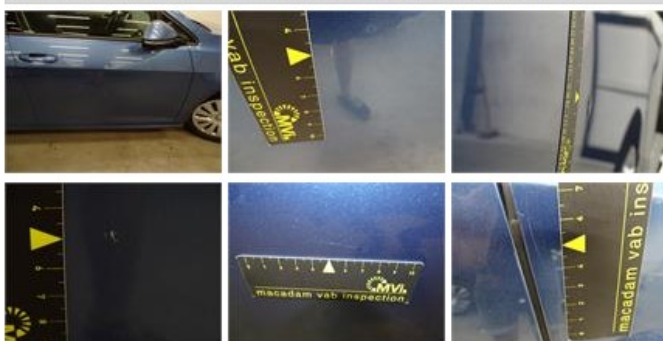
Door F R, Dent(s) and scratch(es), LI - Repair and paint (complete)

318,35

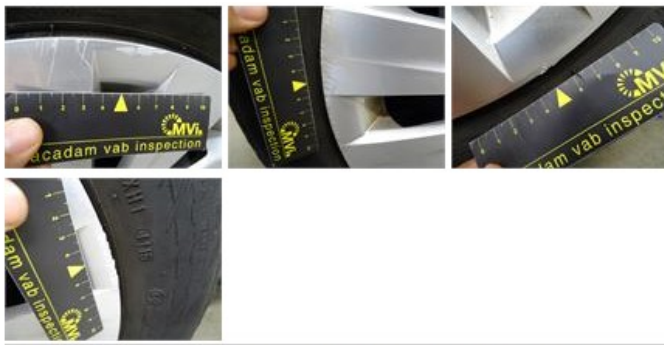
Wheel cover R R, Scratch(es), E - Replace

30,00

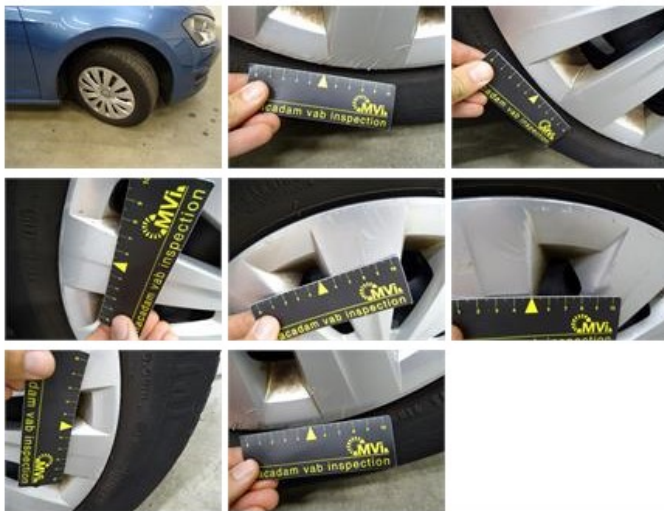
Wheel cover F R, Scratch(es), E - Replace

30,00

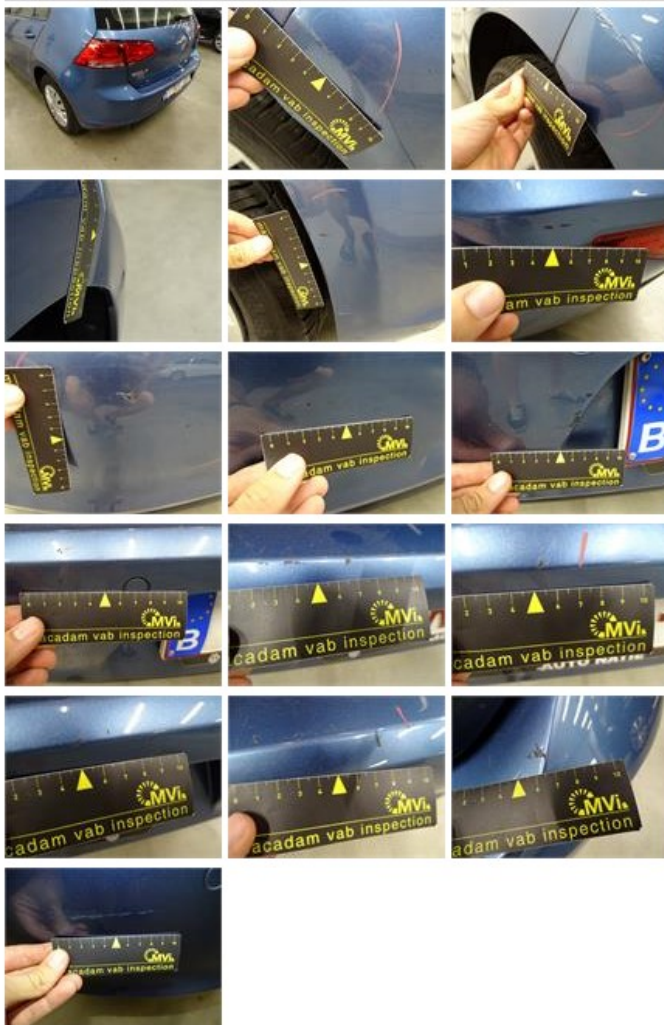
Bumper R, Dent(s) and scratch(es), LI - Repair and paint (complete)

211,80
