**BMW 1 HATCH: 1KTF292**

**Limited Technical Inspection**

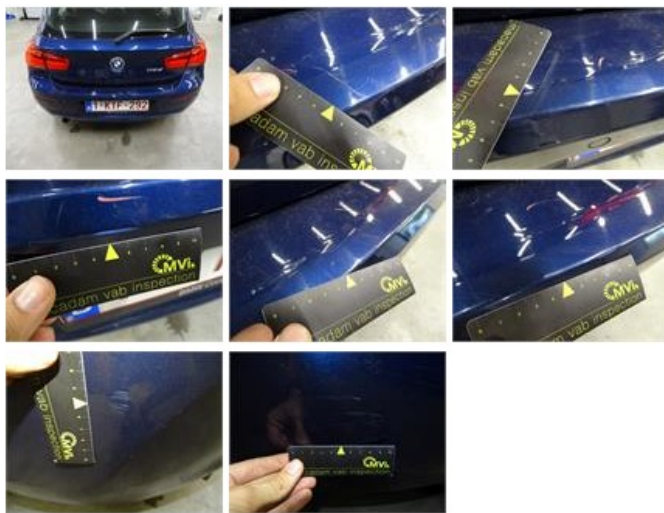
| Bumper R, Scratch(es), LI - Repair and paint (complete) | 211,80 |

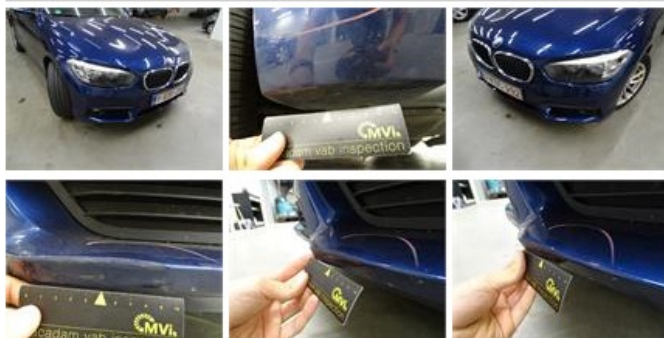
| Bumper F, Dent(s) and scratch(es), LI - Repair and paint (complete) | 211,80 |

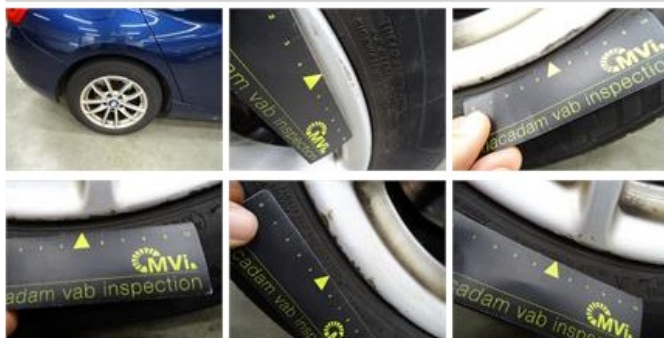
| Alloy rim R R, Scratch(es), LI - Repair and paint (complete) | 95,00 |

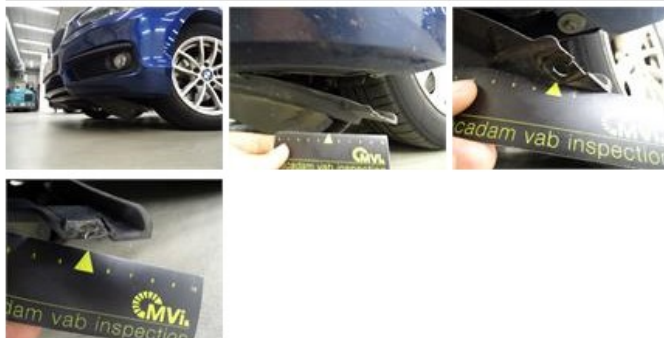
| Spoiler F L, Deformed / Strained, E - Replace | 42,00 |

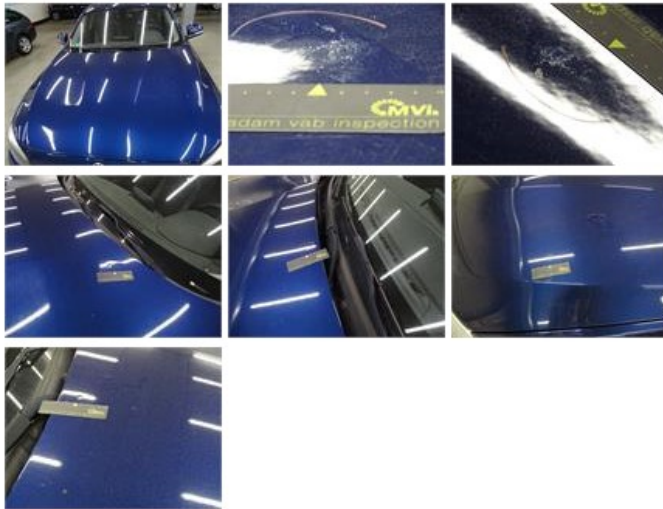
Bonnet, Chemical polution, LI - Repair and paint (complete)

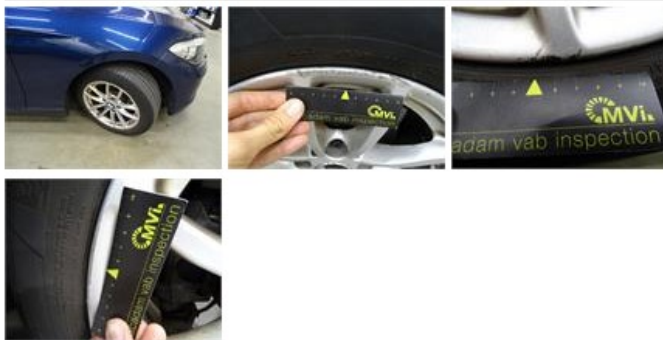
Alloy rim F R, Scratch(es), LI - Repair and paint (complete)
