#### SKODA OCTAVIA COMBI: 1NRR356

#### Limited Technical Inspection

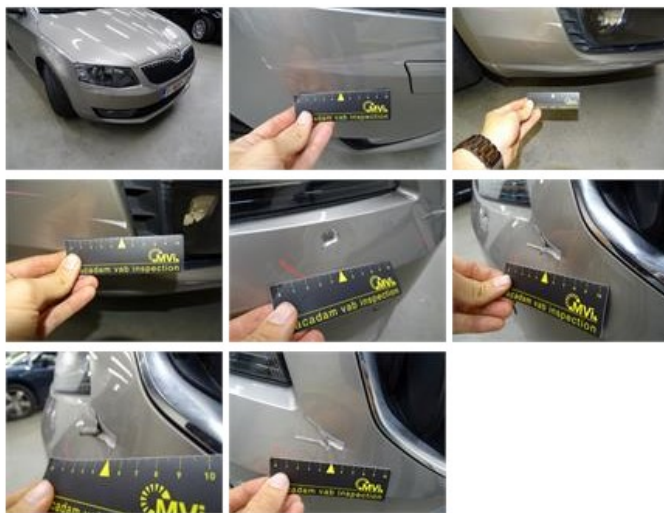
| Bumper F, Broken, Le - Replace and paint | 735,00 |

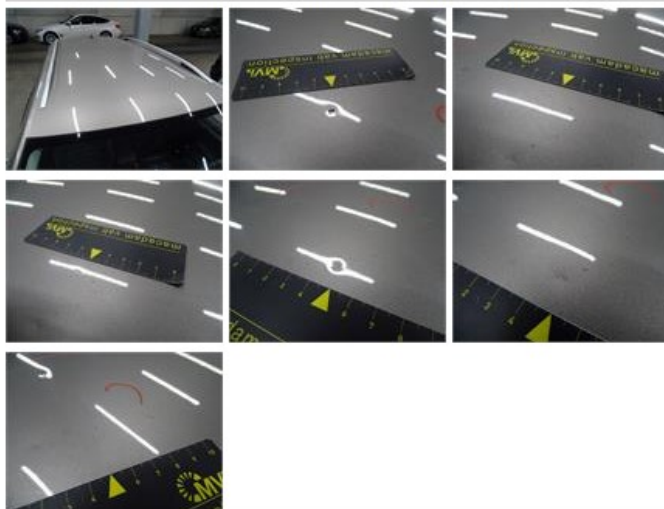
Roof, Dent(s) and scratch(es), LI - Repair and paint (complete)

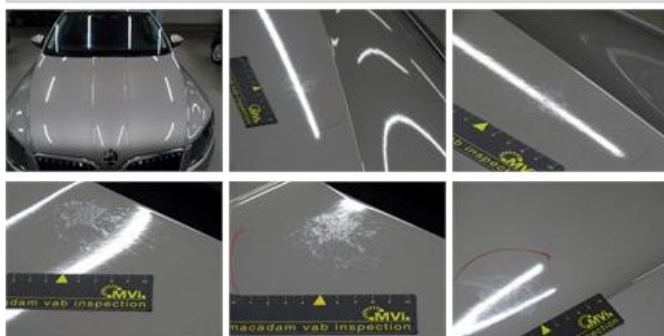
Bonnet, Chemical polution, LI - Repair and paint (complete)

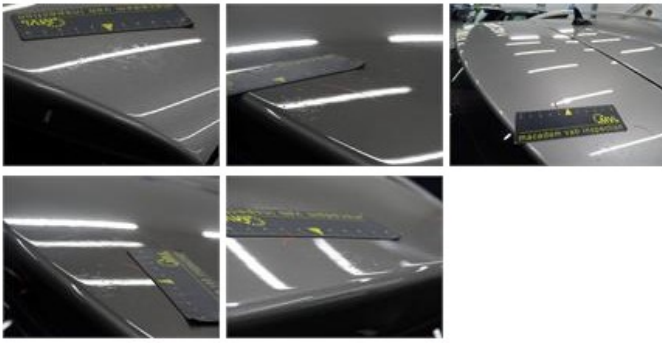
Rear spoiler, Chemical polution, LI - Repair and paint (complete)
