## VOLVO S60: 1KLP744

| Vinnumber: | <b>YV1FS74C1G2393757</b> | Versionname: | <b>2.0 D2 SUMMUM</b> |

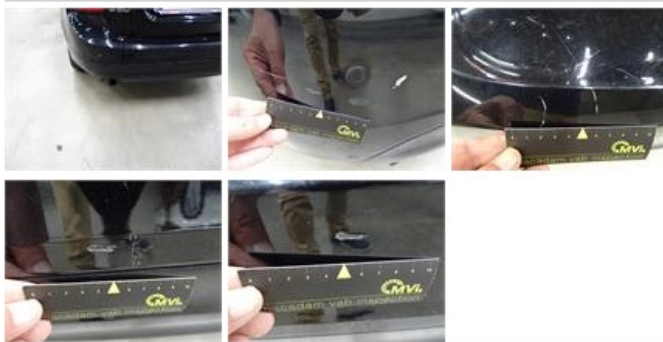
| Bumper R, Scratch(es), LI - Repair and paint (complete) | 211,80 |

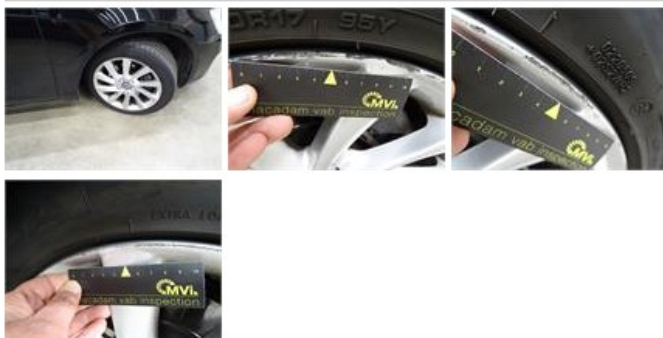
| Alloy rim F R, Scratch(es), LI - Repair and paint (complete) | 95,00 |
