## VOLKSWAGEN PASSAT VARIANT: 1LCB679

| Vinnumber: | WVWZZZ3CZGE021882 | Versionname: | 1.6 TDI VARIANT COMFORTLINE |

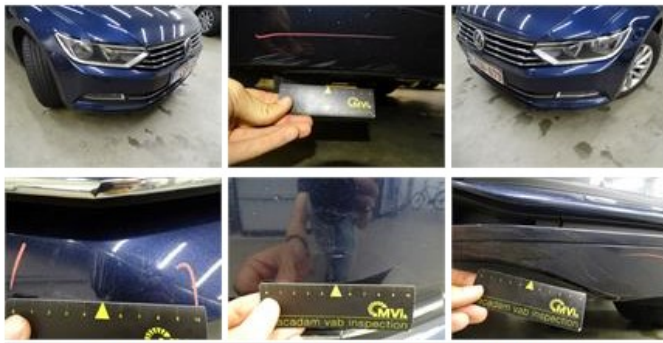
| Bumper F, Scratch(es), LI - Repair and paint (complete) | 211,80 |

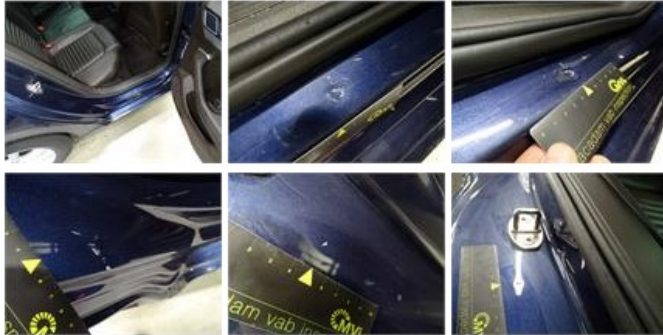
Rocker panel inner R R, Dent(s), LI - Repair and paint (complete)

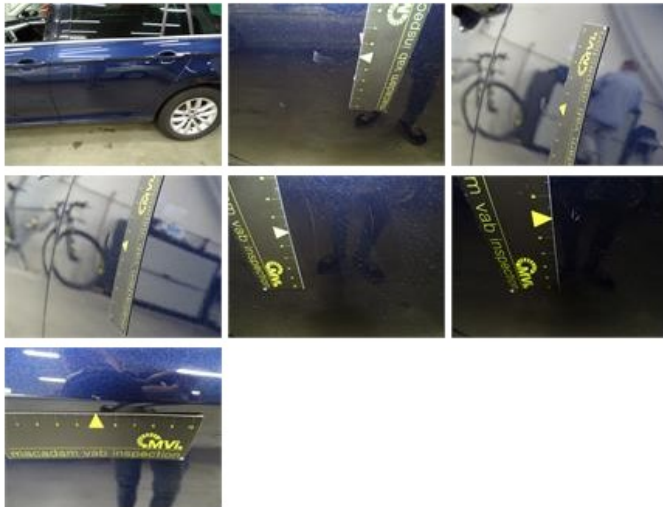
Door R L, Dent(s) and scratch(es), LI - Repair and paint (complete)

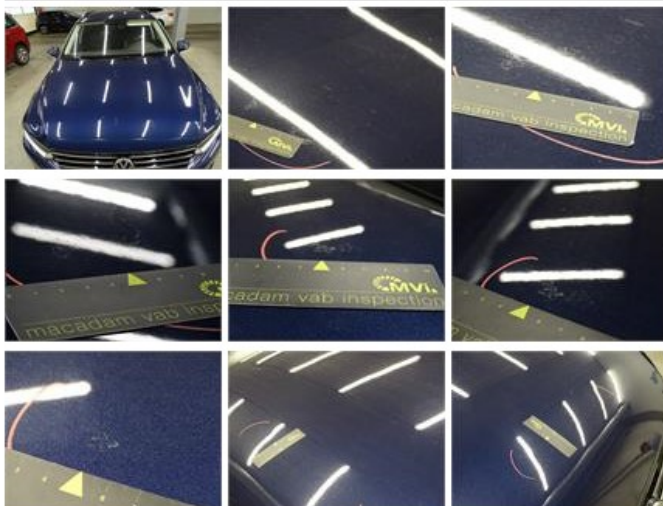
Bonnet, Chemical polution, LI - Repair and paint (complete)

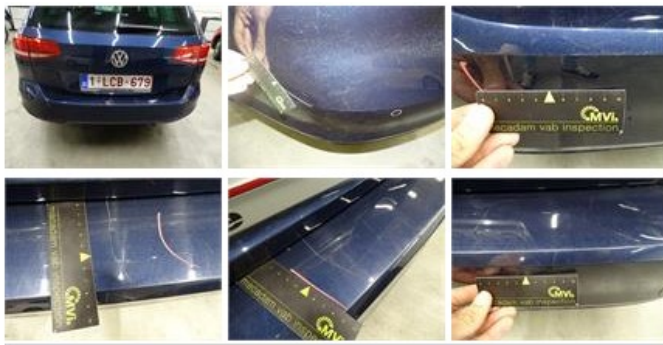
Bumper R, Scratch(es), LI - Repair and paint (complete)

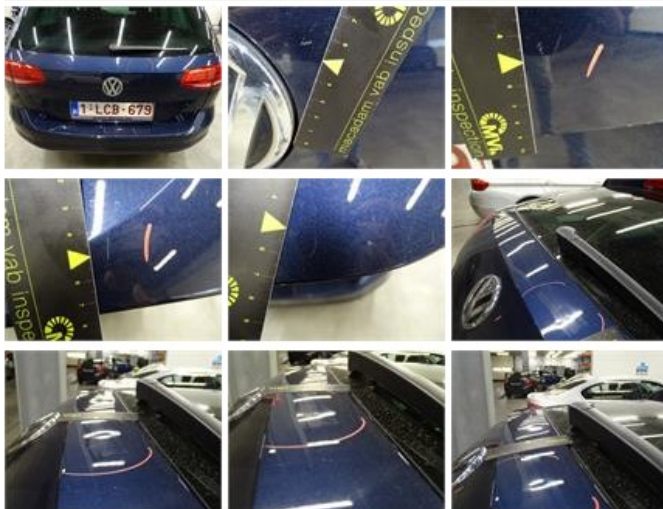
Tailgate, Dent(s) and scratch(es), LI - Repair and paint (complete)

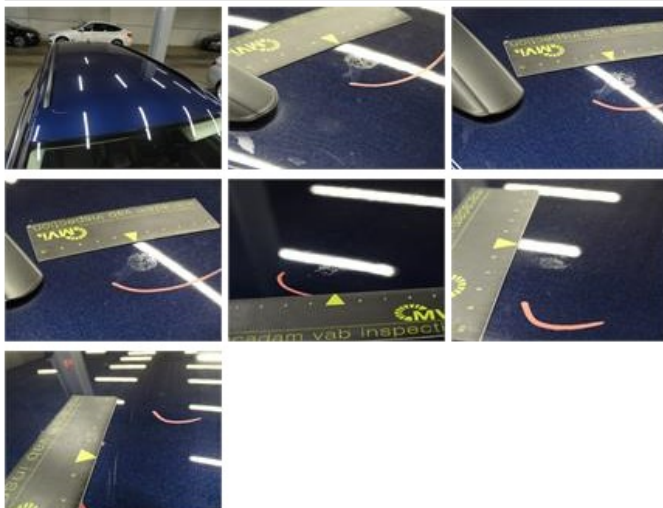
Roof, Chemical polution, LI - Repair and paint (complete)

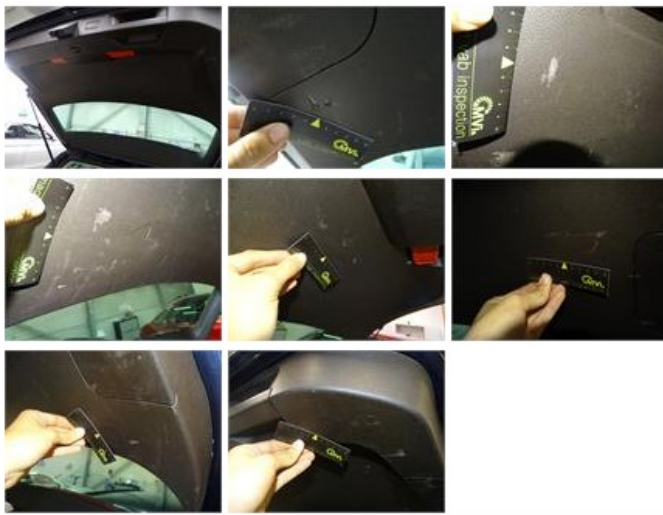
Trunk lid covering R, Scratch(es), Smart repair

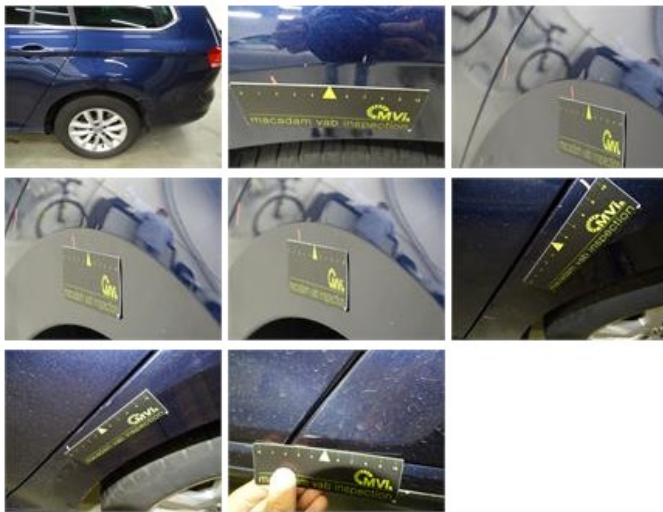
Wing R L, Dent(s) and scratch(es), LI - Repair and paint (complete)
