VOLKSWAGEN Golf: 1HDC674

Limited Technical Inspection

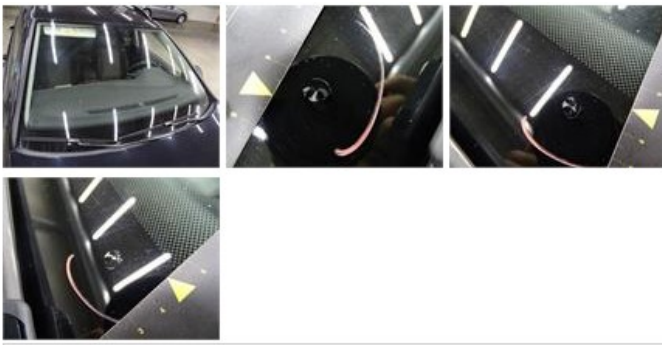
Total cost ex VAT	2443,76
Door R R, Scratch(es), Acceptable	0,00
<i>No pictures to display</i>	
Interior, Dirty, Acceptable	0,00
<i>No pictures to display</i>	
Windscreen, Stone chip(s), E - Replace	0,00

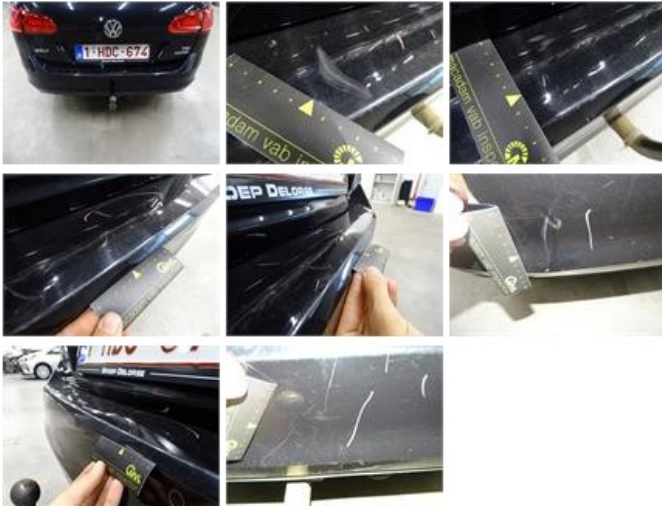
Bumper R, Dent(s) and scratch(es), LI - Repair and paint (complete) 211,80

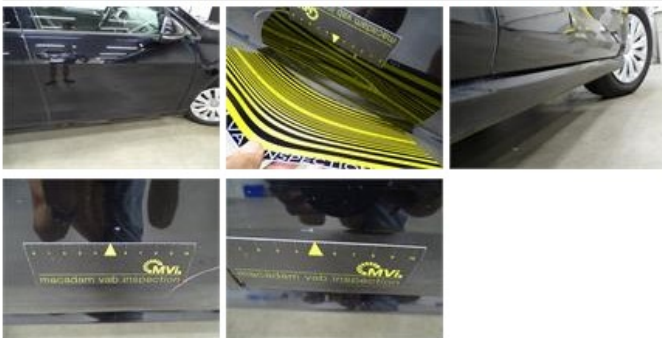
Door F R, Dent(s) and scratch(es), LI - Repair and paint (complete) 318,35

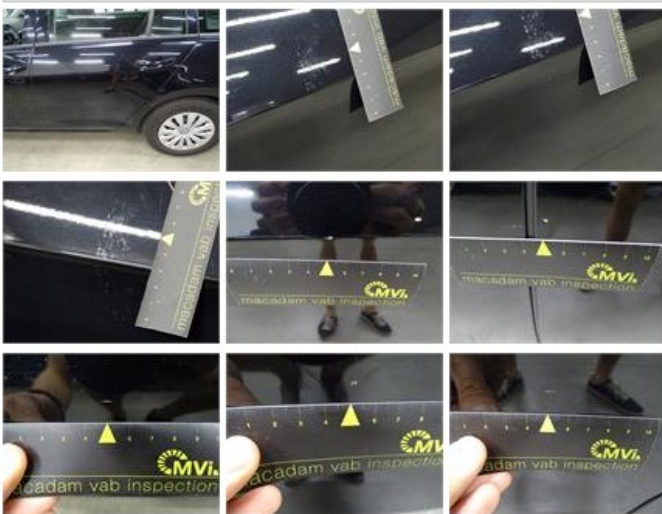
Door R L, Chemical polution, LI - Repair and paint (complete) 318,35

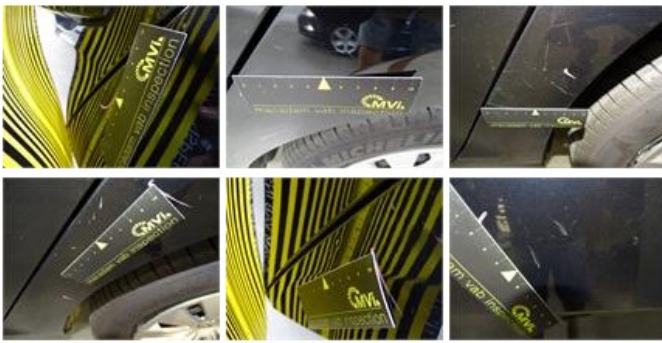
Wing R L, Dent(s) and scratch(es), LI - Repair and paint (complete) 0,00

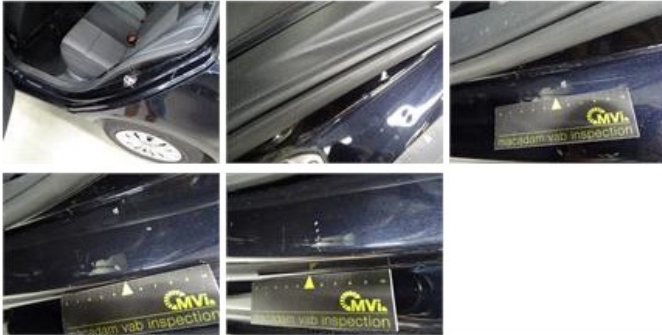
Rocker panel inner R L, Dent(s), LI - Repair and paint (complete) 115,56

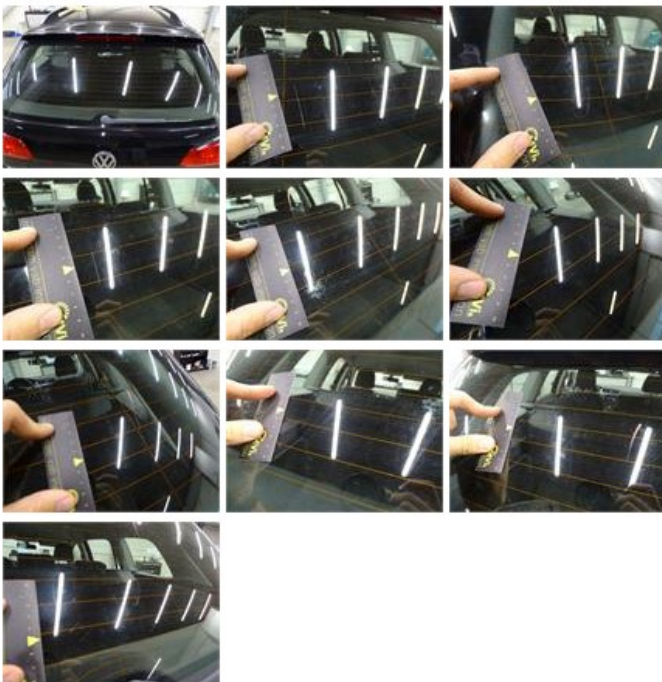
Rear window, Scratch(es), E - Replace 0,00

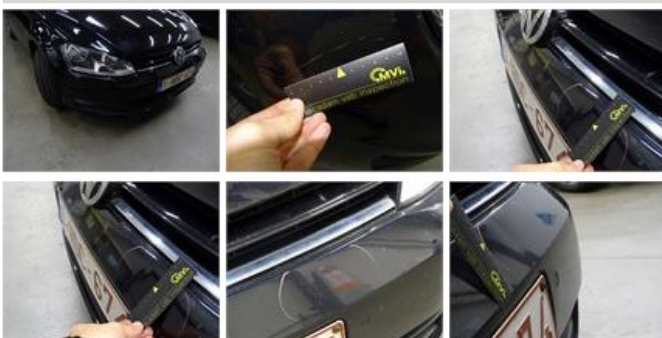
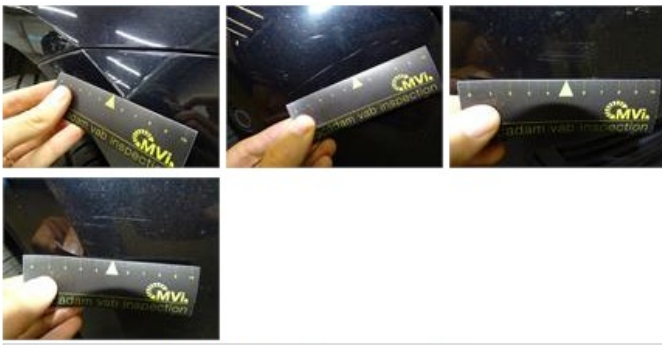
Bumper F, Dent(s) and scratch(es), LI - Repair and paint (complete) 211,80

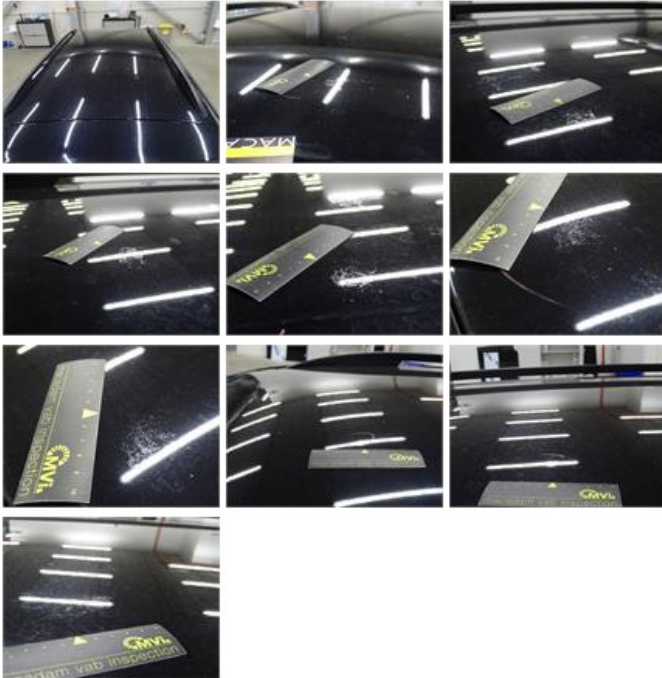
Roof, Chemical polution, LI - Repair and paint (complete) 481,50

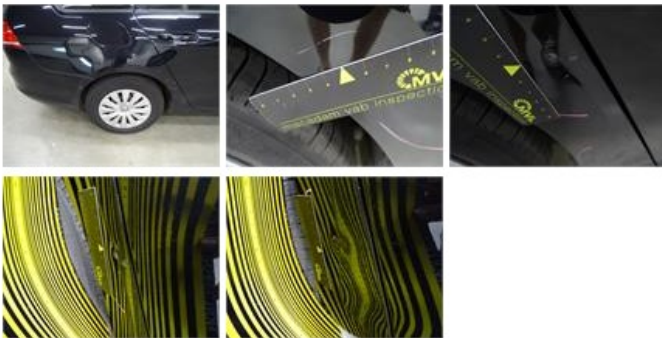
Wing R R, Dent(s) and scratch(es), LI - Repair and paint (complete) 308,20

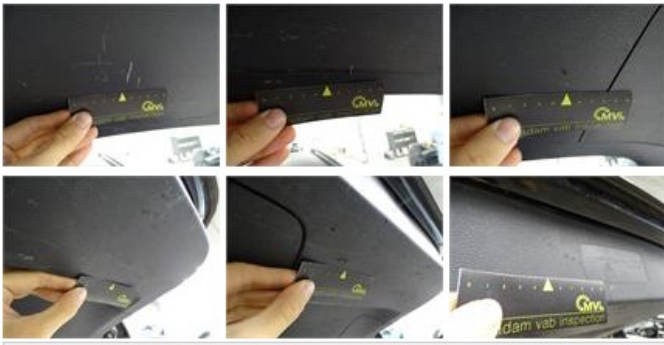
Trunk lid covering R, Scratch(es), Smart repair 110,64
