| PEUGEOT 308: 1DRZ520 | | | |
| Vinnumber: | VF34E9HP0CS192189 | Versionname: | 308 SW Access 92PK |

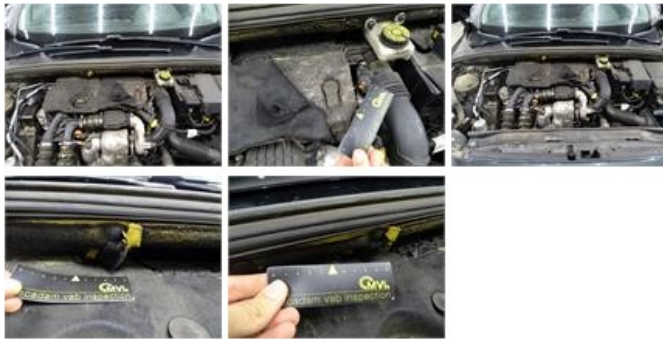
| Engine protective plate, Deformed / Strained, Acceptable | 0,00 |

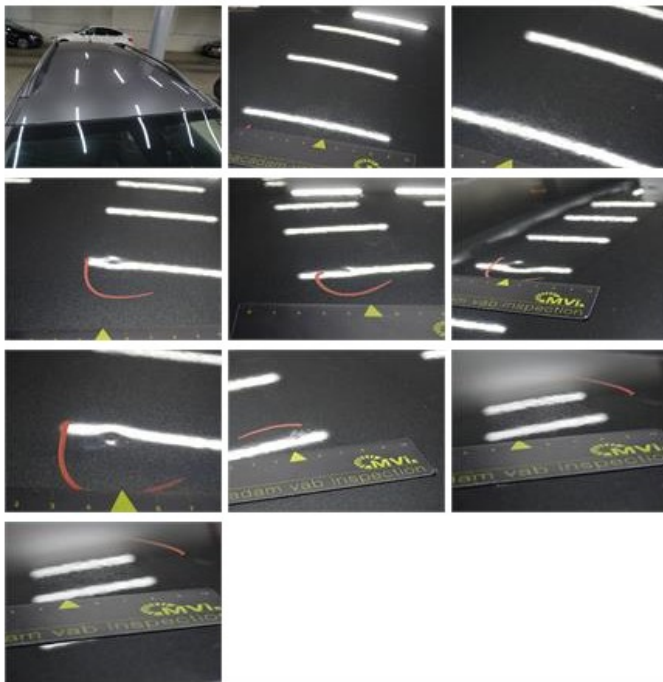
| Roof, Chemical polution, LI - Repair and paint (complete) | 505,50 |

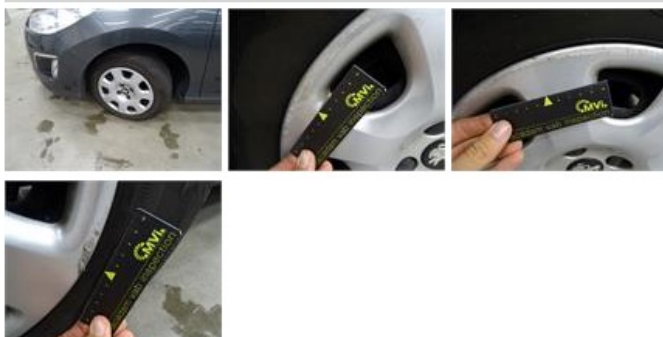
| Wheel cover F L, Scratch(es), E - Replace | 30,00 |

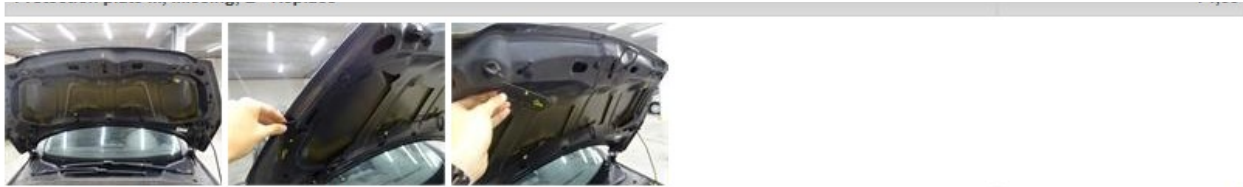
| Protection plate M, Missing, E - Replace | 74,00 |
