**RENAULT CAPTUR: 1KAZ143**

| Vinnumber: | <b>VF12R5A1H52604079</b> | Versionname: | <b>0.9 TCE 90 ENERGY INTENS ECO2</b> |

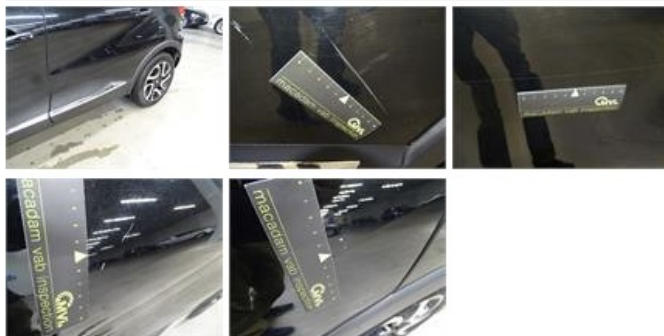
Door R L, Scratch(es), LI - Repair and paint (complete)

254,68
