**CITROEN C4 Picasso: 1GJA077**

**Limited Technical Inspection**

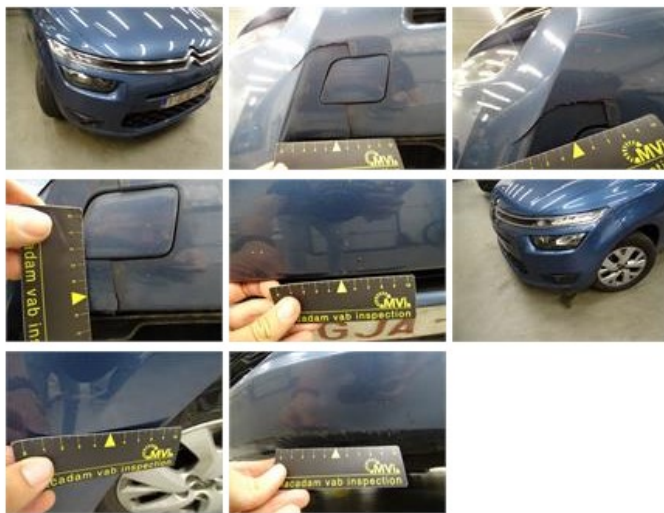
| Bumper F, Broken, Le - Replace and paint | <b>735,00</b> |

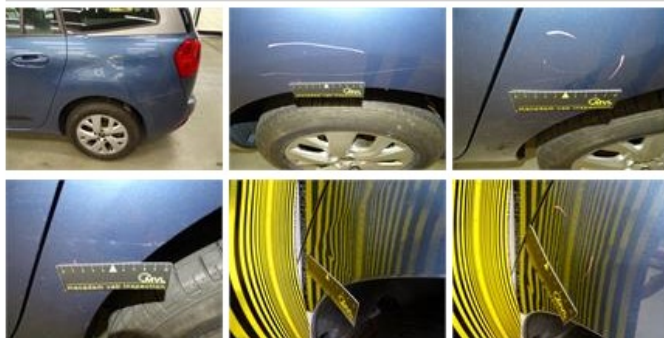
| Wing R L, Dent(s) and scratch(es), LI - Repair and paint (complete) | 308,20 |

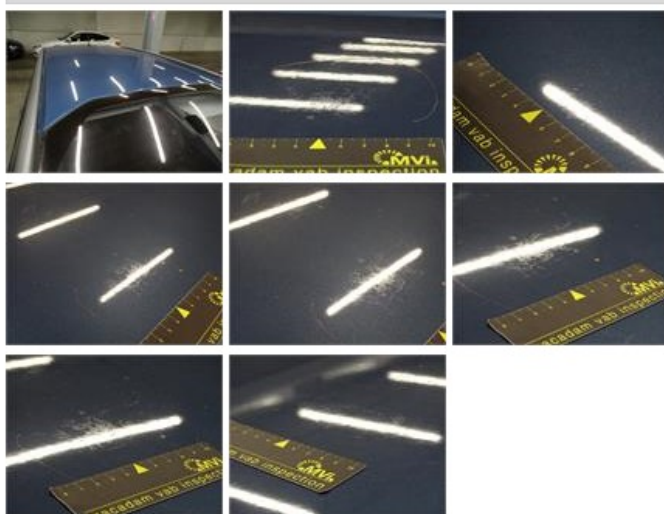
| Roof, Chemical polution, LI - Repair and paint (complete) | 481,50 |

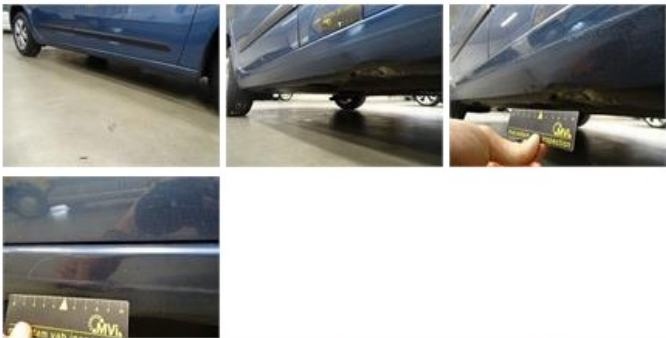
| Sill outer R, Dent(s) and scratch(es), LI - Repair and paint (complete) | 310,50 |

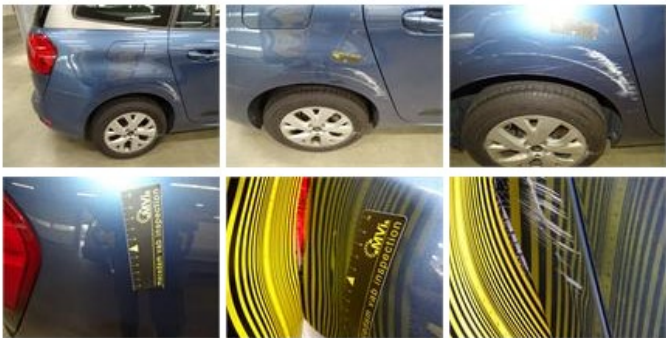
| Wing R R, Dent(s) and scratch(es), LI - Repair and paint (complete) | 308,20 |

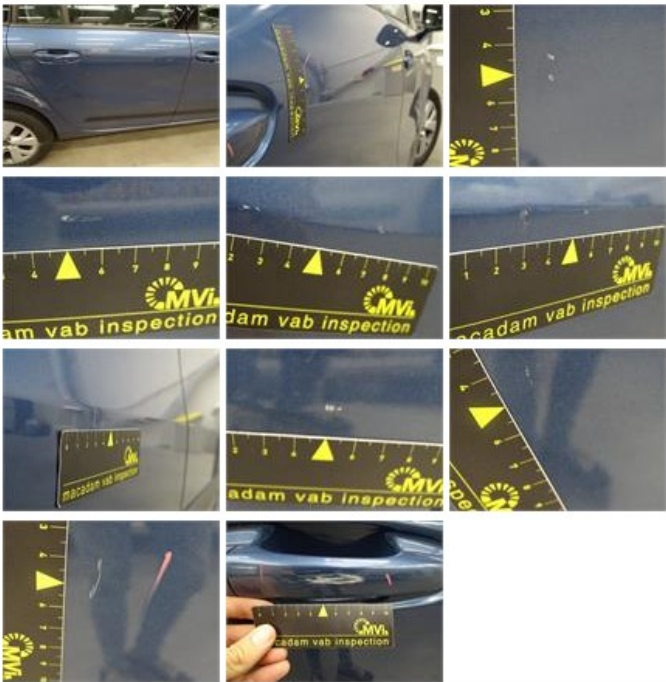
| Door R R, Dent(s) and scratch(es), LI - Repair and paint (complete) | 318,35 |
