**VOLKSWAGEN Crafter 35 MWB: 1BEM313**

**Limited Technical Inspection**

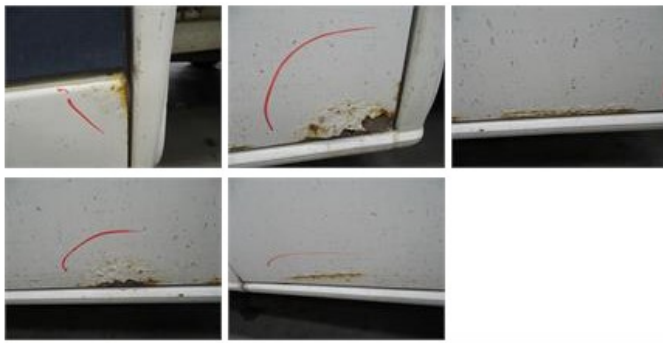
| Door R L, Rust, LI - Repair and paint (complete) | 238,76 |

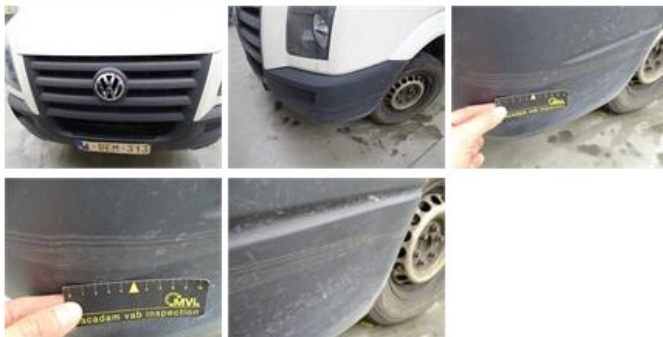
Bumper F, Scratch(es), Smart repair

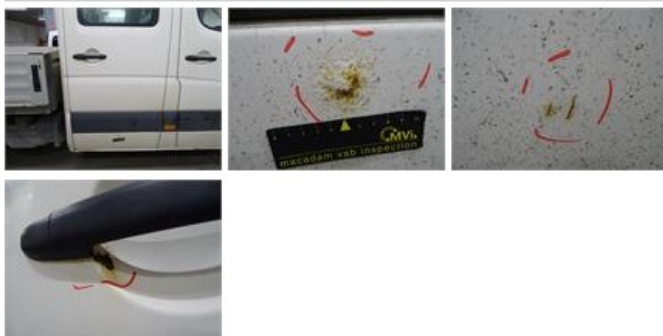
Door R R, Rust, LI - Repair and paint (complete)

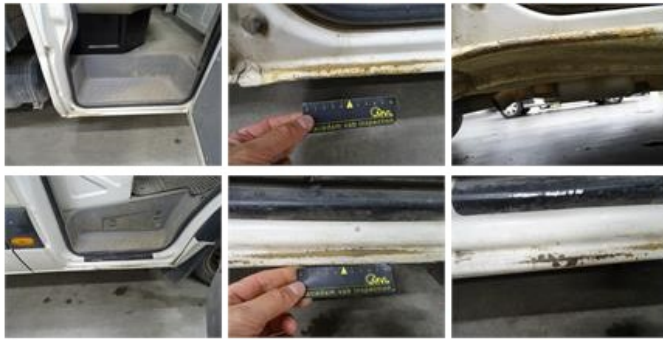
Sill outer R, Dent(s) and scratch(es), LI - Repair and paint (complete)

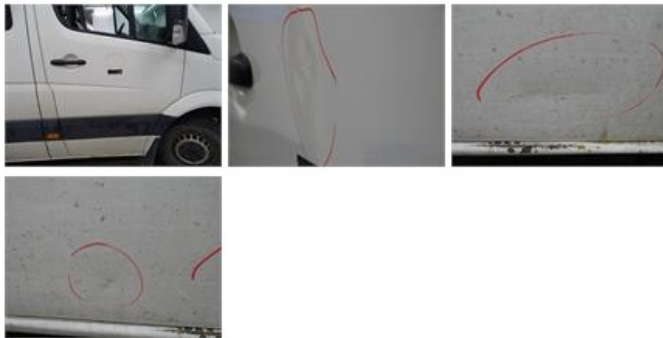
Door F R, Dent(s) and scratch(es), LI - Repair and paint (complete)

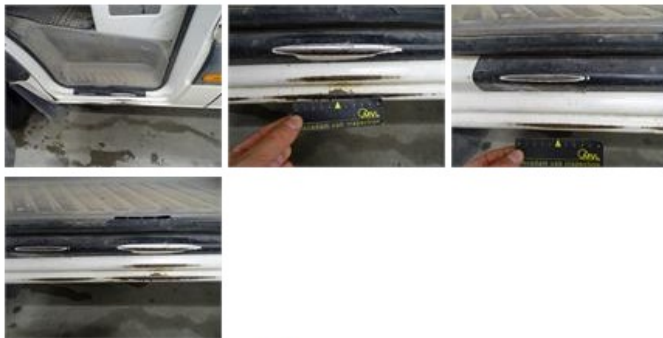
Sill outer L, Rust, LI - Repair and paint (complete)
