**VOLKSWAGEN Golf: GG6927**

**Limited Technical Inspection**

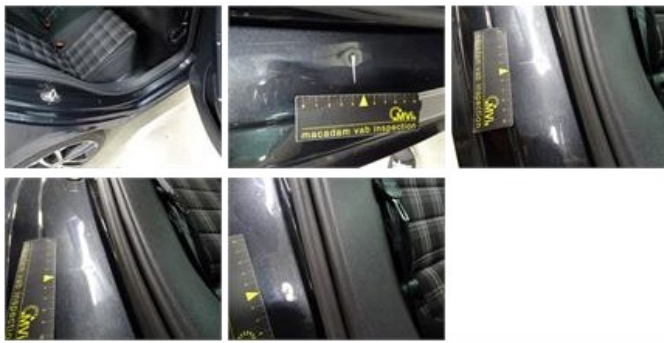
| Rocker panel inner R R, Dent(s), LI - Repair and paint (complete) | 115,56 |

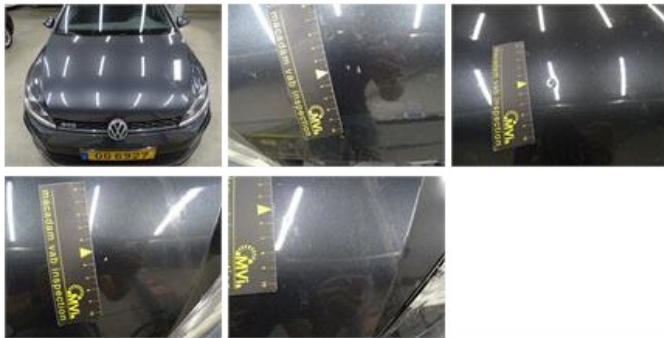
Bonnet, Stone chip(s), Acceptable

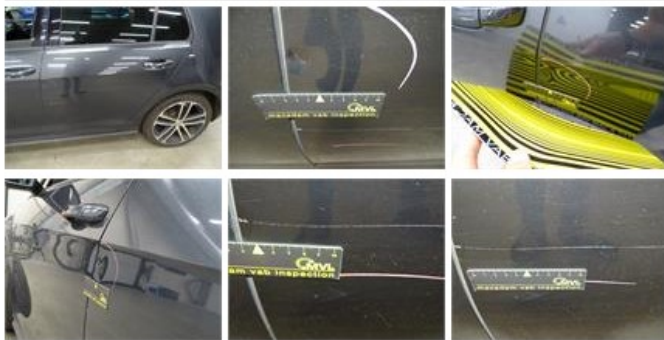
Door R L, Dent(s) and scratch(es), LI - Repair and paint (complete)

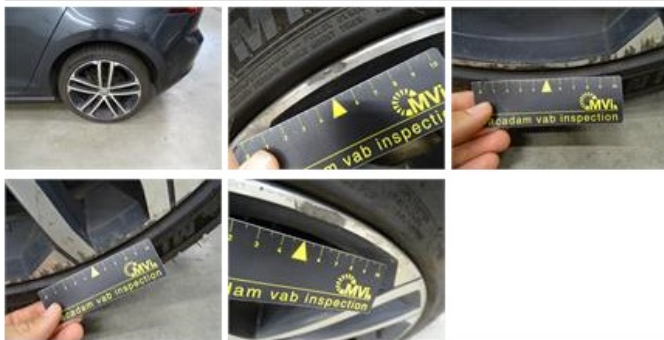
Alloy rim R L polished, Scratch(es), LI - Repair and paint (complete)

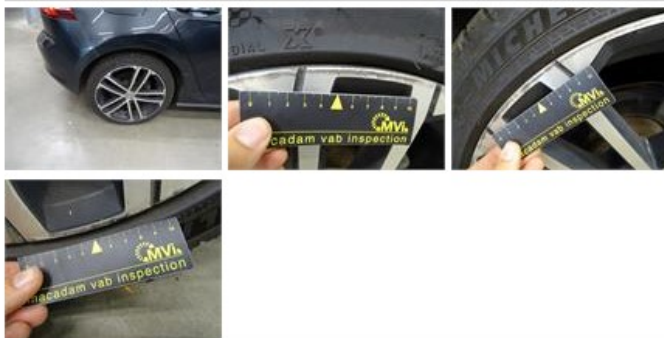
Alloy rim R R polished, Scratch(es), LI - Repair and paint (complete)

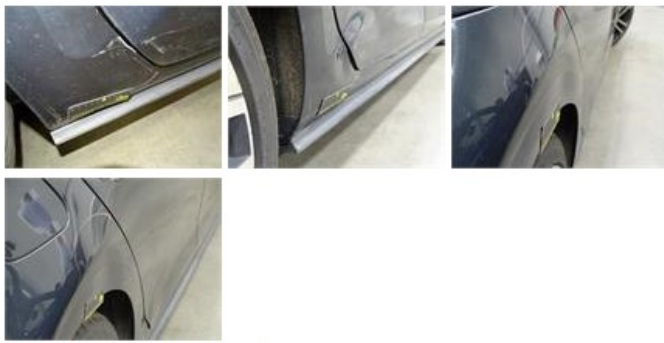
Wing R R, Dent(s) and scratch(es), LI - Repair and paint (complete)

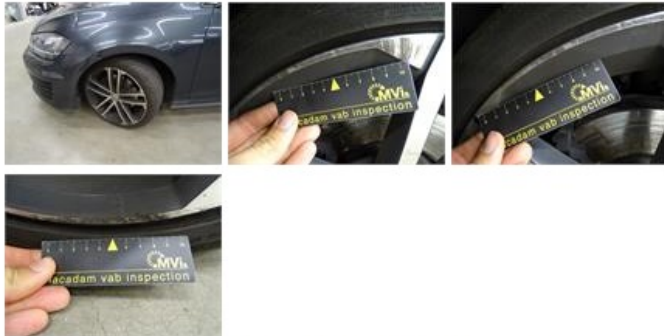
Alloy rim F L polished, Scratch(es), LI - Repair and paint (complete) 95,00

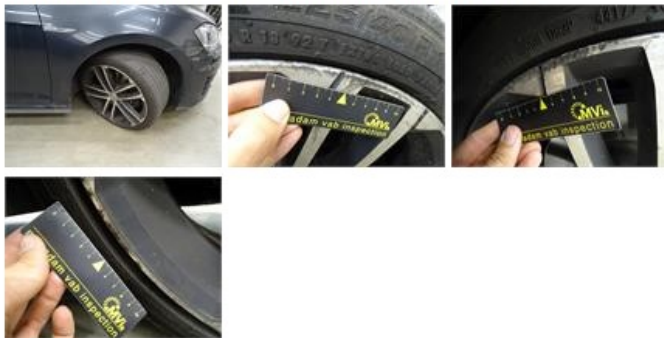
Alloy rim F R polished, Scratch(es), LI - Repair and paint (complete) 95,00

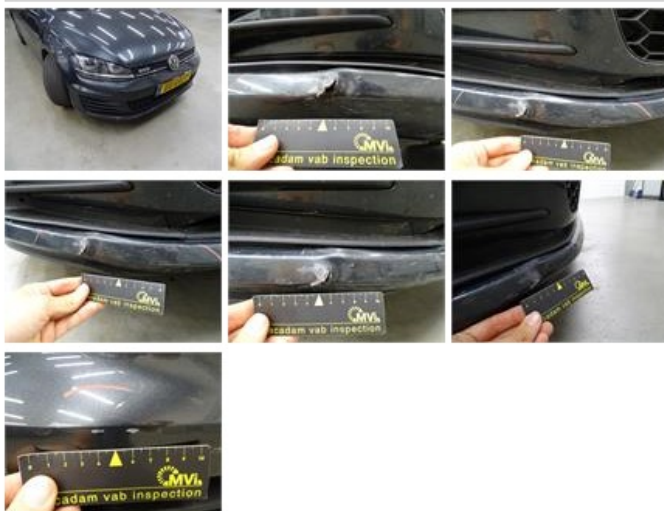
Bumper F, Broken, Le - Replace and paint 735,00

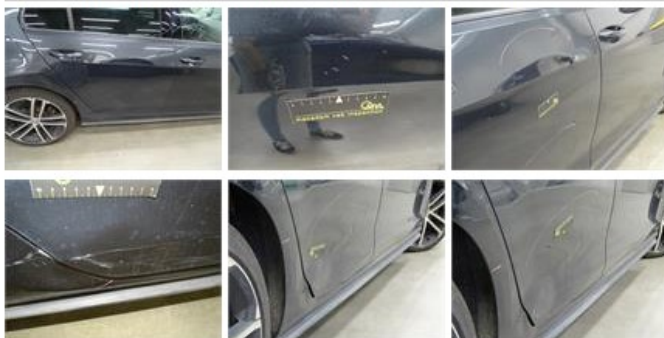
Door R R, Dent(s) and scratch(es), LI - Repair and paint (complete) 462,35

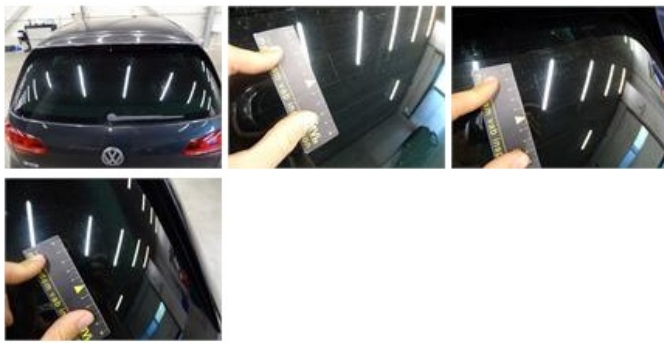
Rear window, Scratch(es), Acceptable 0,00

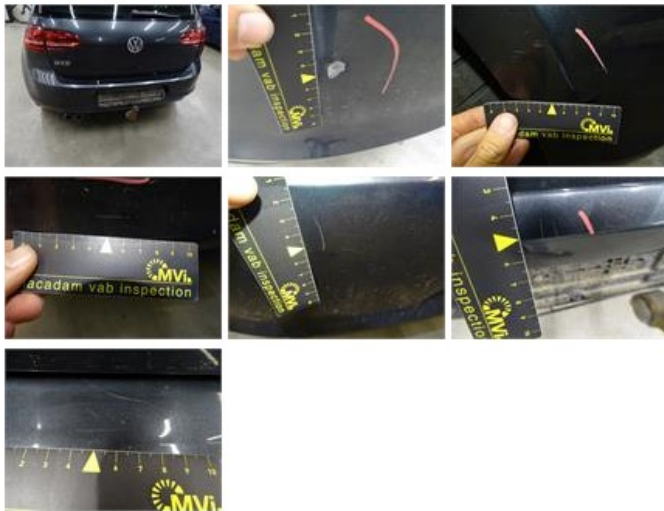
Bumper R, Scratch(es), LI - Repair and paint (complete)
