**TOYOTA Auris: 1HHP097**

| Vinnumber: | <b>SB1ZS3JE20E097190</b> | Versionname: | <b>AURIS TOUR.SP.HSD Dynamic CVT 99PK Aut.</b> |

**Limited Technical Inspection**

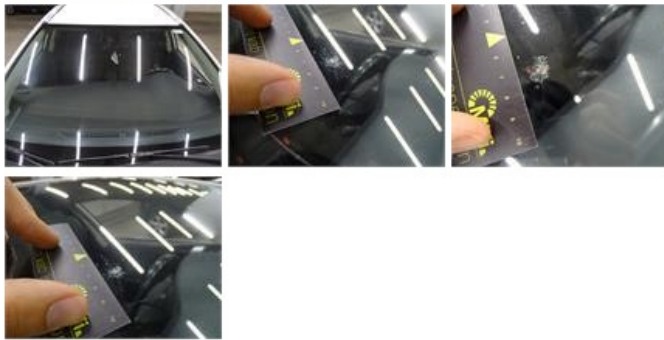
Windscreen, Stone chip(s), E - Replace

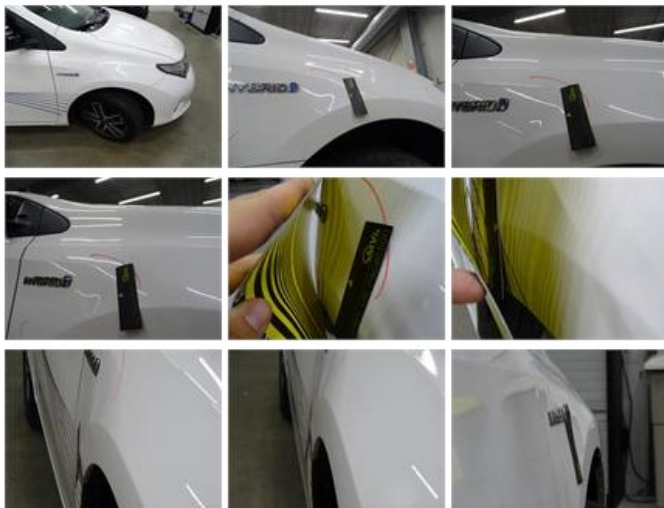
Wing F R, Dent(s), LI - Repair and paint (complete)

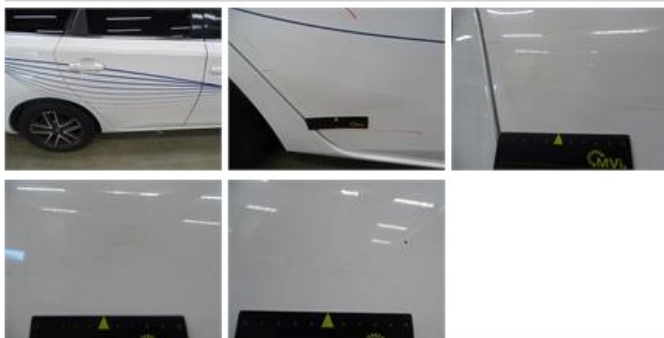
Door R R, Scratch(es), LI - Repair and paint (complete)

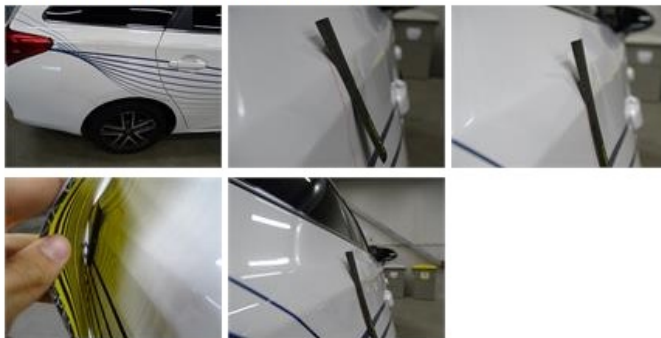
Wing R R, Dent(s), LI - Repair and paint (complete)

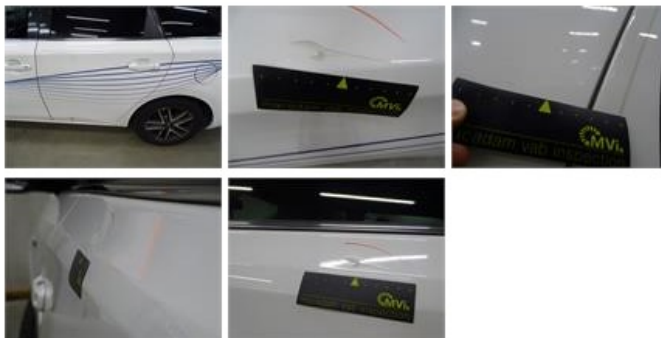
Door R L, Dent(s) and scratch(es), LI - Repair and paint (complete)

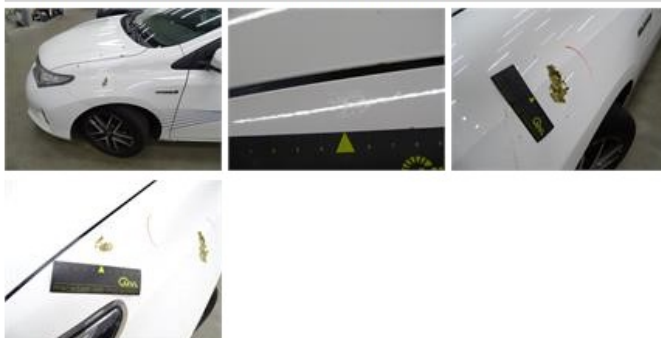
Wing F L, Chemical polution, LI - Repair and paint (complete)

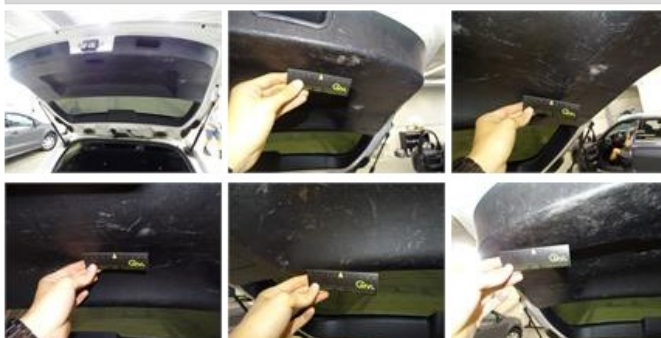
Trunk lid covering R, Scratch(es), Smart repair

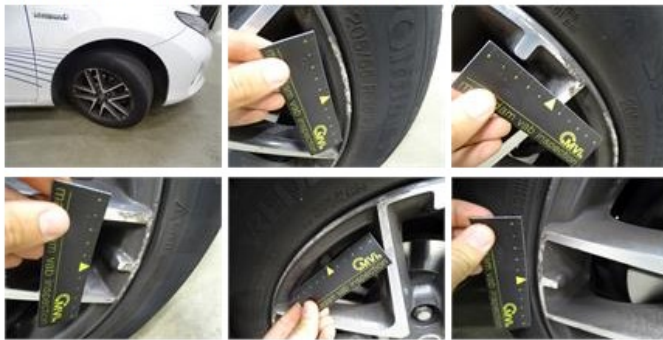
Alloy rim F R, Scratch(es), LI - Repair and paint (complete)

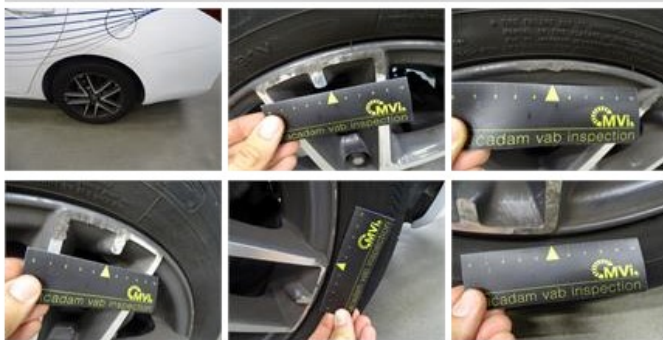
Alloy rim R L, Scratch(es), LI - Repair and paint (complete)

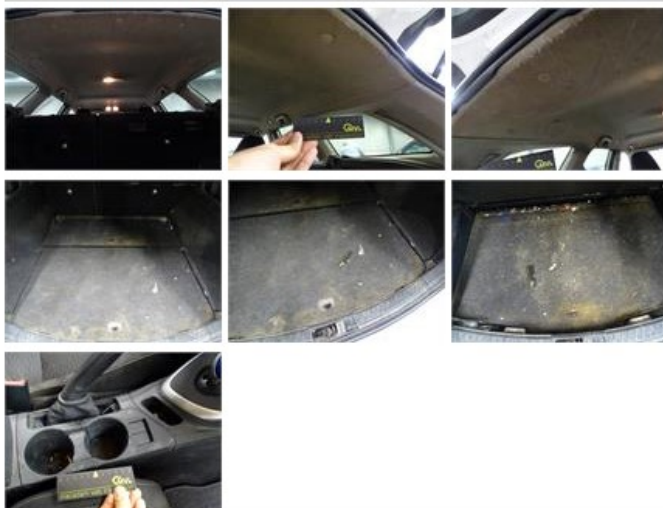
Interior, Dirty, Cleaning

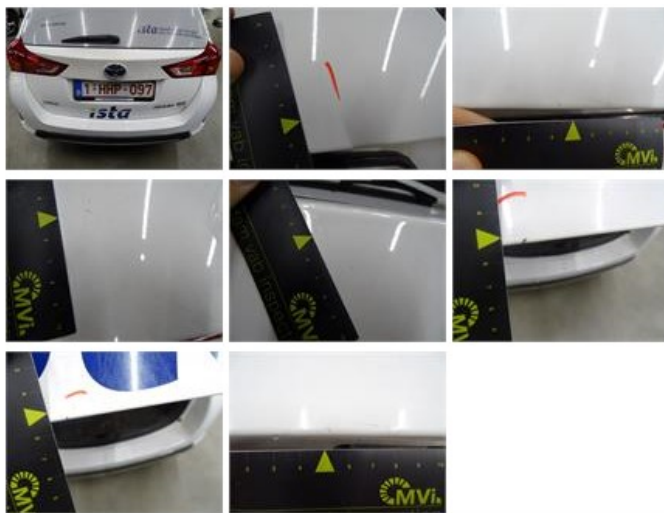
Tailgate, Scratch(es), LI - Repair and paint (complete)

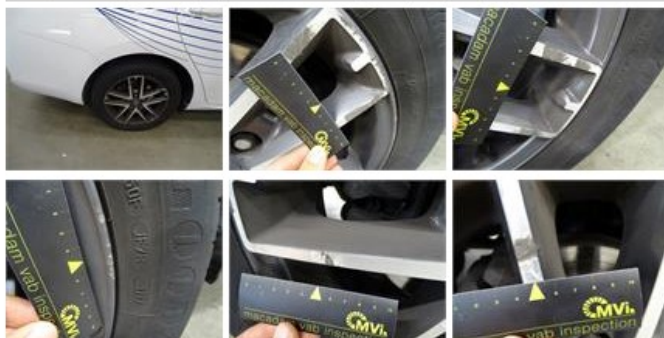
Alloy rim R R, Scratch(es), LI - Repair and paint (complete)

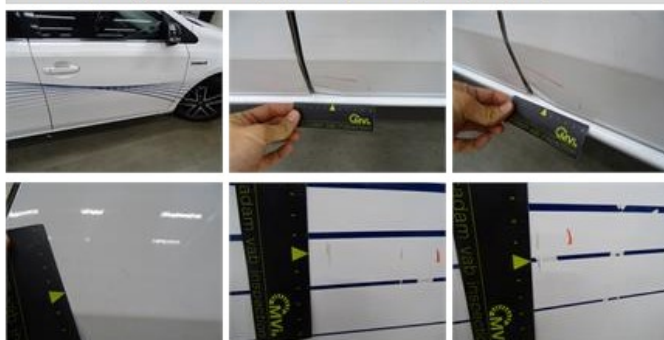
Door F R, Dent(s) and scratch(es), LI - Repair and paint (complete)

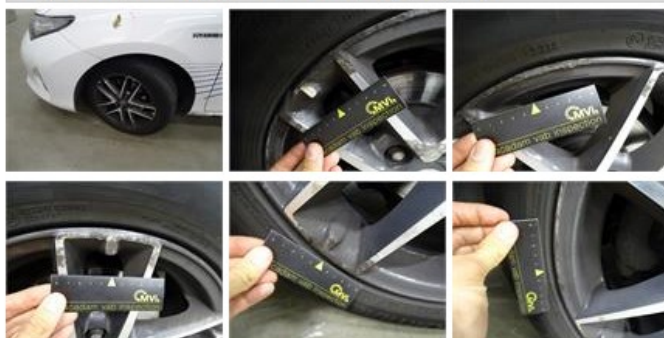
Alloy rim F L, Scratch(es), LI - Repair and paint (complete)
