**VOLKSWAGEN Touran: 1GIF734**

**Limited Technical Inspection**

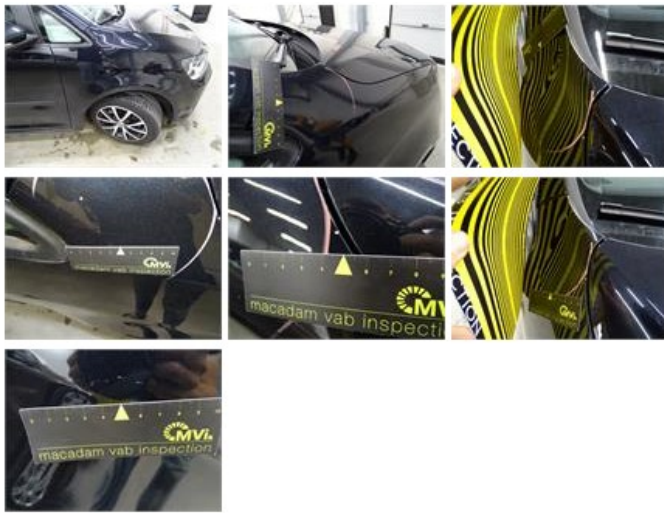
| Wing F R, Dent(s) and scratch(es), LI - Repair and paint (complete) | 220,18 |

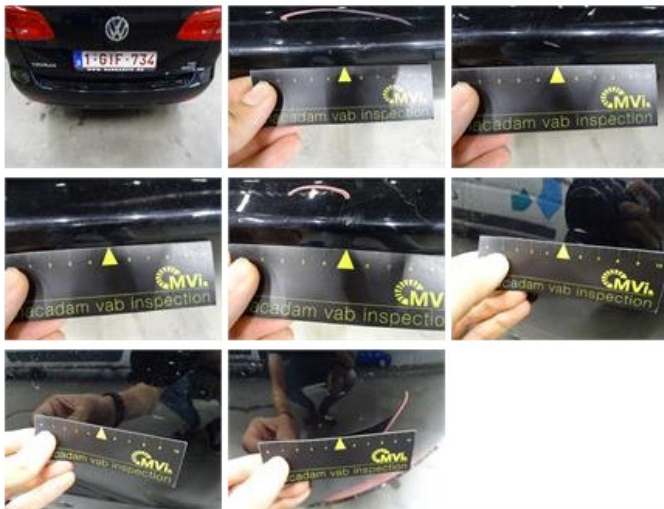
Bumper R, Scratch(es), Acceptable 0,00

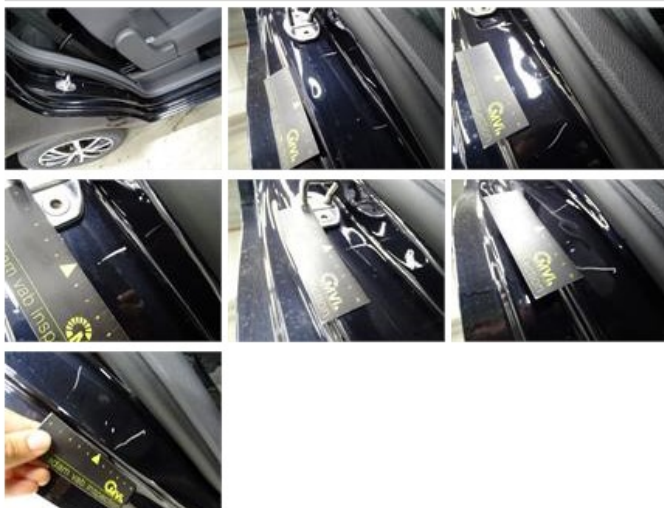
Rocker panel inner R R, Dent(s), LI - Repair and paint (complete) 115,56

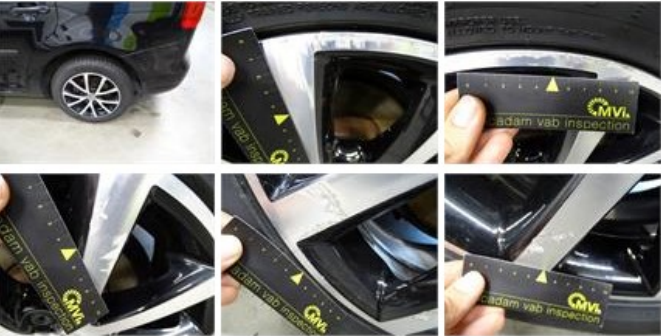
| Alloy rim R L polished, Scratch(es), LI - Repair and paint (complete) | 95,00 |

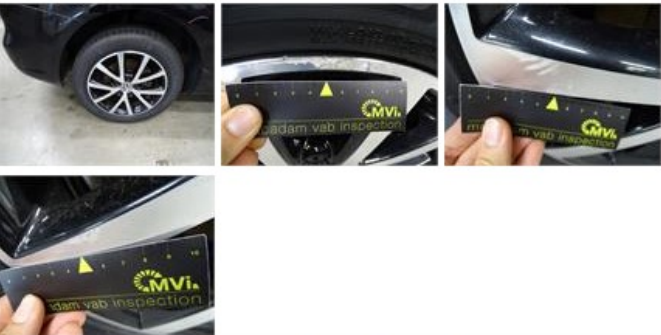
| Alloy rim R R polished, Scratch(es), LI - Repair and paint (complete) | 95,00 |

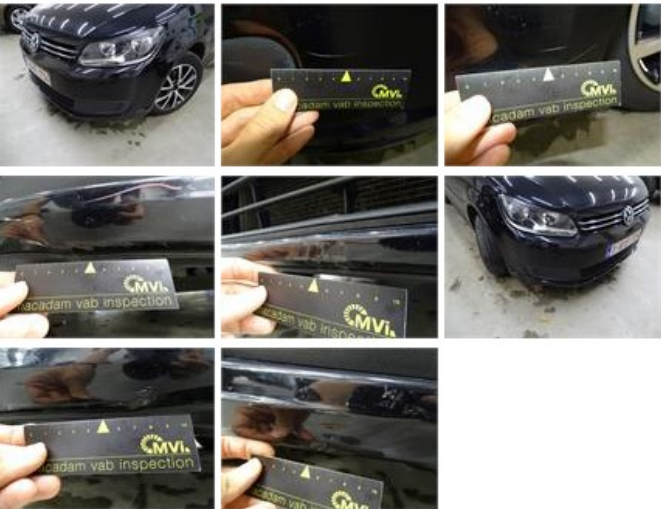
| Bumper F, Scratch(es), LI - Repair and paint (complete) | 211,80 |

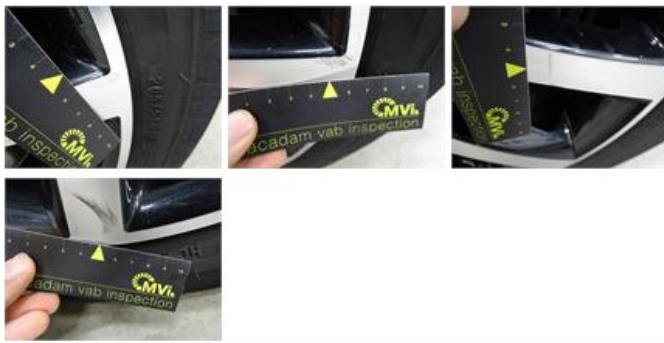
| Alloy rim F L polished, Scratch(es), Acceptable | 0,00 |

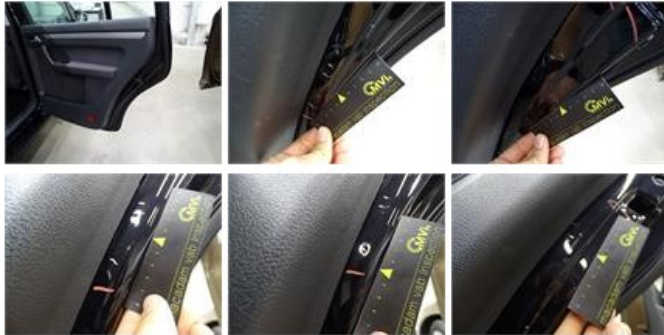
Door frame R R, Dent(s), It - Spot repair

115,56

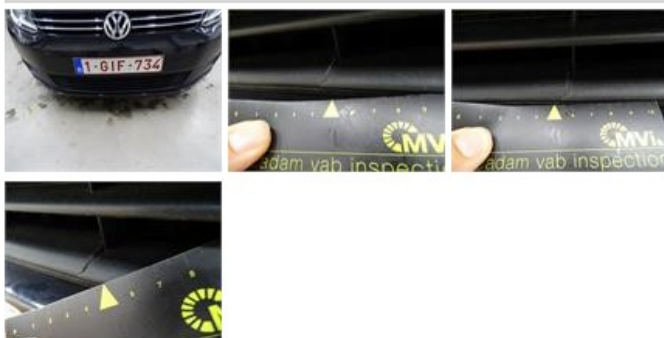
Bumper grille, Broken, E - Replace

32,40

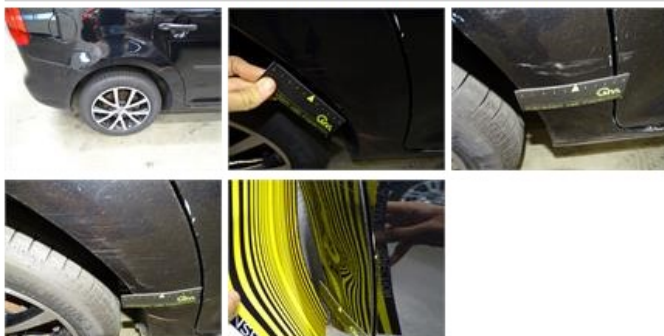
Wing R R, Dent(s) and scratch(es), LI - Repair and paint (complete)

308,20

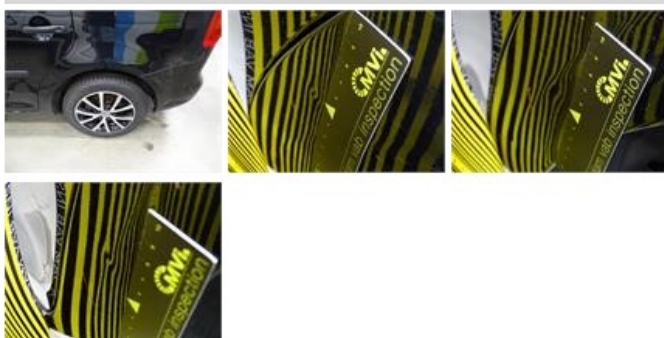
Wing R L, Dent(s), Acceptable

0,00
