**VOLKSWAGEN Touran: 1HZA288**

**Limited Technical Inspection**

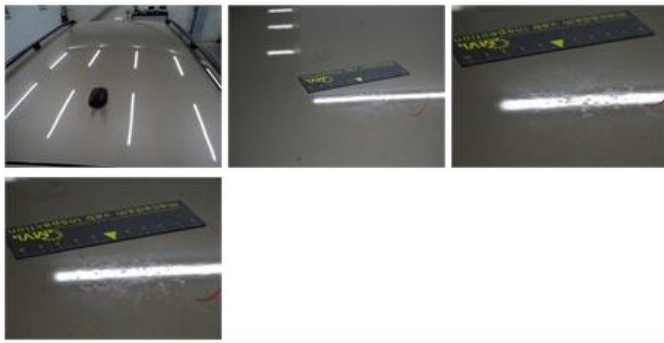
| Roof, Chemical polution, LI - Repair and paint (complete) | 0,00 |

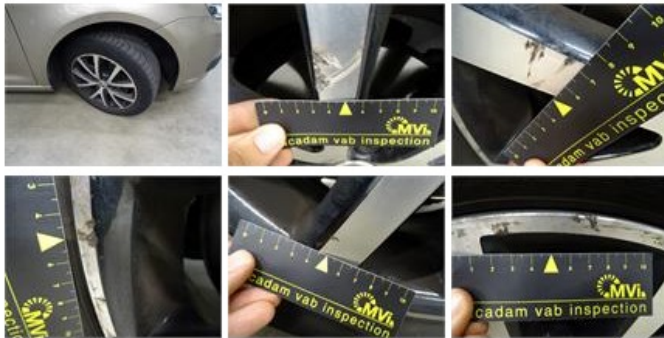
Alloy rim F R polished, Scratch(es), LI - Repair and paint (complete)

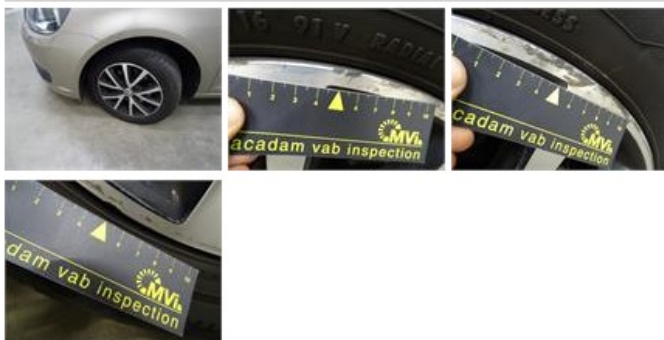
Alloy rim F L polished, Scratch(es), LI - Repair and paint (complete)

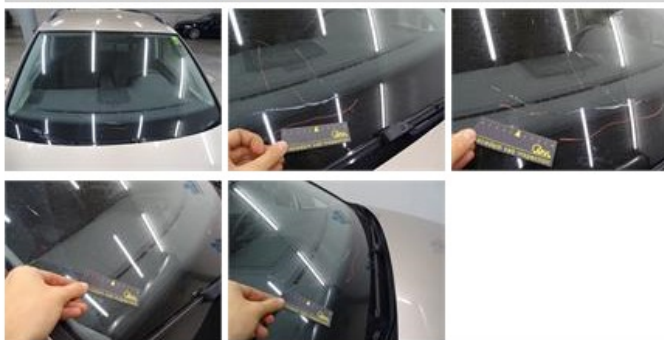
Windscreen, Crack, E - Replace

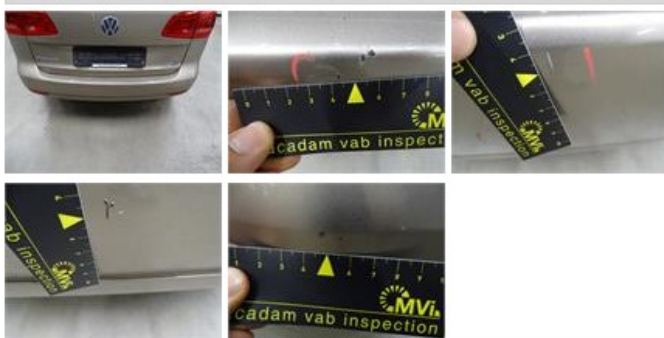
Bumper R, Scratch(es), LI - Repair and paint (complete)

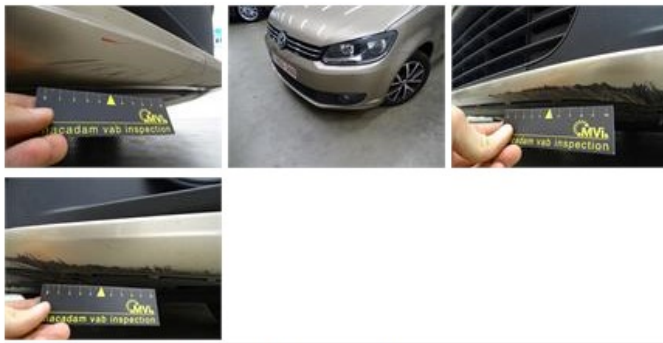
Bumper F, Scratch(es), LI - Repair and paint (partial)

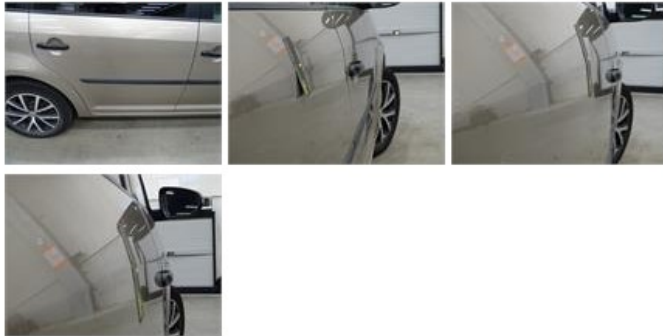
Door R R, Dent(s), PDR - Paintless dent repair 63,00

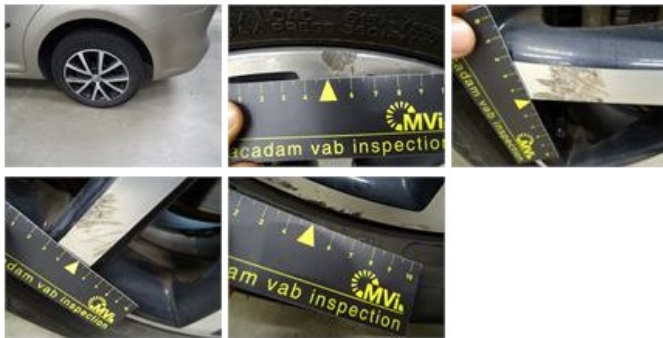
Alloy rim R L polished, Scratch(es), LI - Repair and paint (complete) 95,00

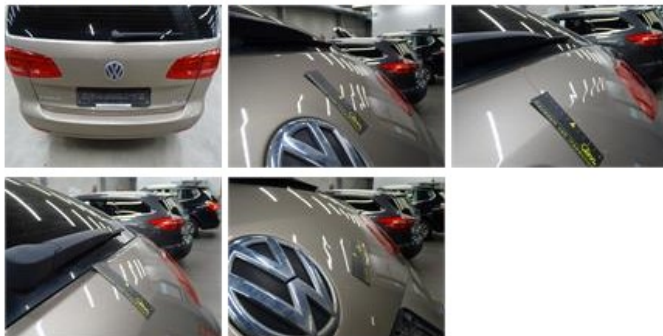
Tailgate, Dent(s), PDR - Paintless dent repair 63,00

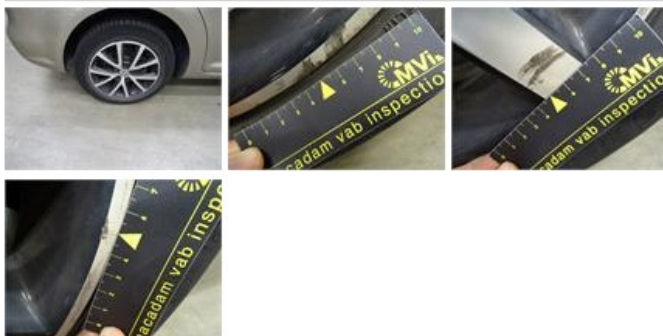
Alloy rim R R polished, Scratch(es), LI - Repair and paint (complete) 95,00
