**PEUGEOT 308 SW: 1LVK324**

**Limited Technical Inspection**

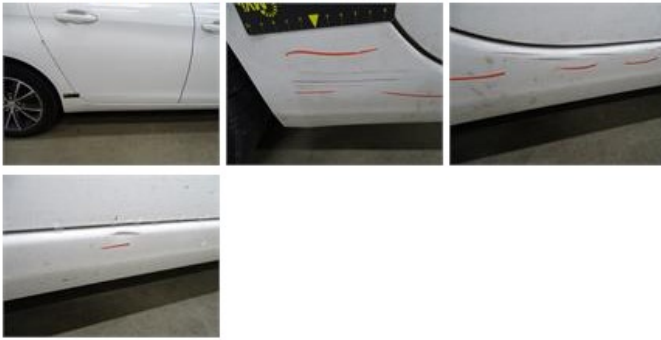
Sill outer R, Scratch(es), LI - Repair and paint (complete)

310,50

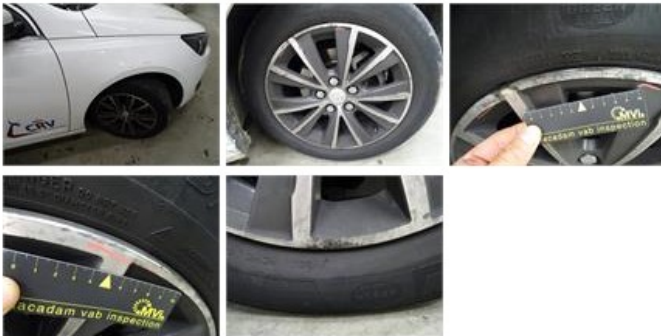
Alloy rim F R polished, Scratch(es), LI - Repair and paint (complete)

95,00

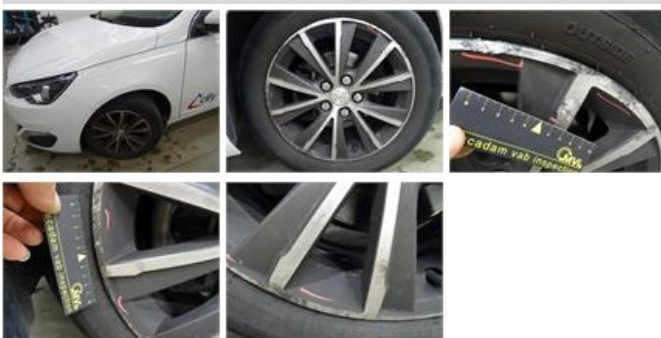
Alloy rim F L polished, Scratch(es), LI - Repair and paint (complete)

95,00

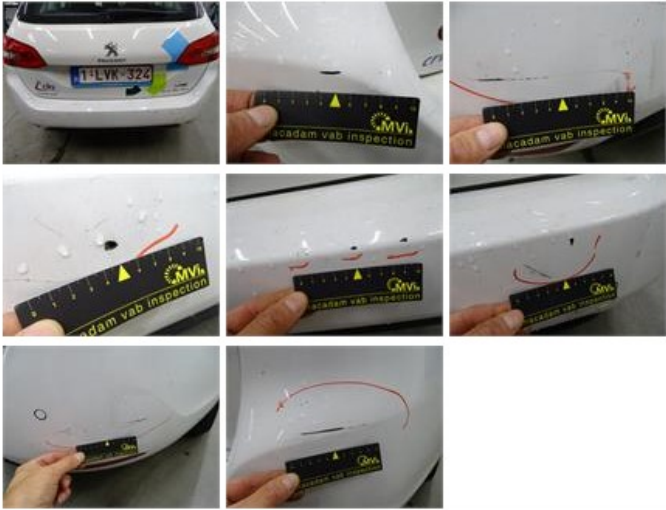
| Bumper R, Scratch(es), LI - Repair and paint (complete) | | 211,80 |
