<b>OPEL Vivaro 2900: 1EHG039</b>			
Vinnumber:	<b>WOLF7B1BECV637240</b>	Versionname:	<b>VIVARO 2900 B/F L2H1 Ecofi.DPF(EU5)115PK</b>
First Registrationdate:	<b>3/12/2012</b>	Fiscalpower:	
Expertise Mileage:	<b>110097</b>	Power Kw:	<b>84</b>
Bodytype:	<b>Transporter</b>	Body color:	<b>White</b>
Gearbox:	<b>MAN 6 VIT</b>	Paint type:	<b>Metalic</b>
Transmission:		Rims summer:	<b>Steel</b>
Fueltype:	<b>Diesel</b>	Oil level:	<b>OK</b>
Battery functioning:	<b>Yes</b>	Parking lot:	<b>2305</b>
Number of doors:	<b>5</b>		
Number of seats:	<b>3</b>		
Number head rests:	<b>3</b>		
Rims summer:	<b>Steel</b>		
Category:	<b>Light Commercial Vehicle</b>		
Oil level:	<b>OK</b>

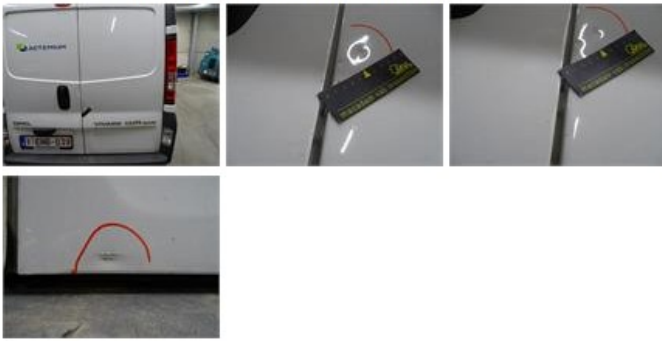
<b>Trunk door R R, Dent(s) and scratch(es), It - Spot repair</b>	<b>115,56</b>
--	---------------

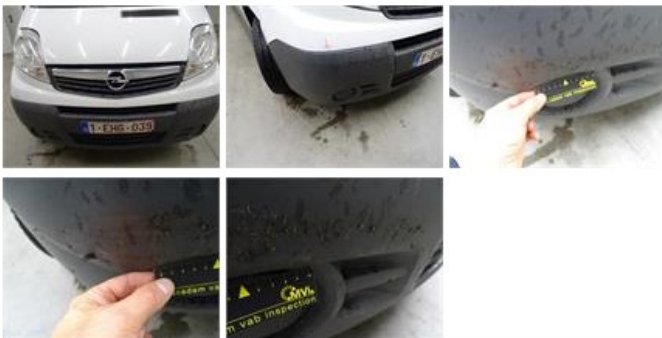
Bumper F, Scratch(es), Smart repair 110,64

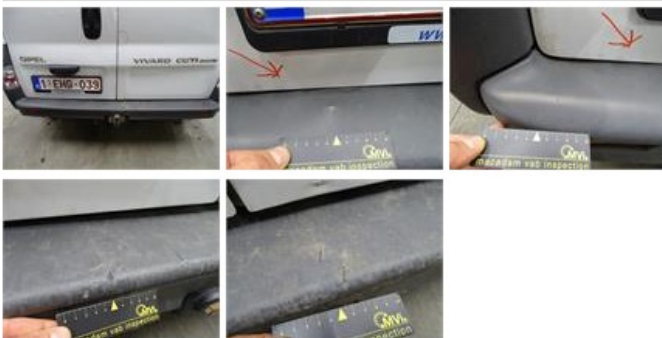
Bumper R, Dent(s) and scratch(es), E - Replace 329,40
