**BMW 5 TOURING: 1KVG738**

| Vinnumber: | <b>WBA5L11060G322910</b> | Versionname: | <b>2.0 518D (100KW) TOURING</b> |

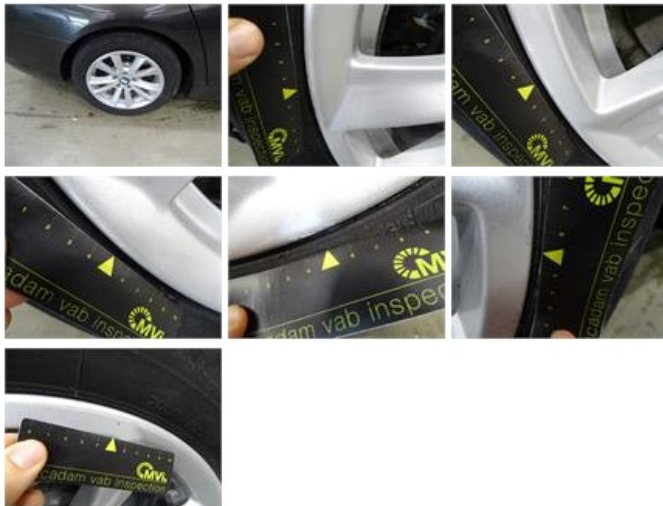
Alloy rim R R, Scratch(es), LI - Repair and paint (complete)

95,00

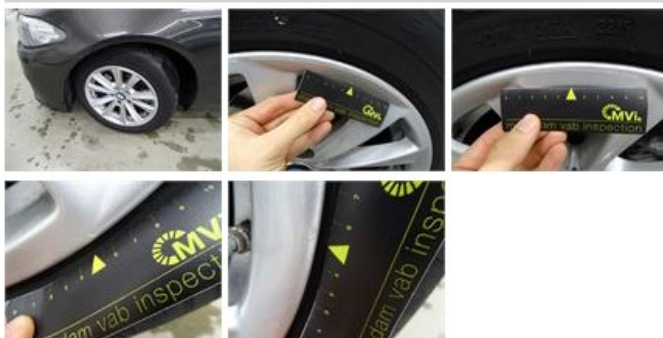
Alloy rim F L, Scratch(es), LI - Repair and paint (complete)

95,00

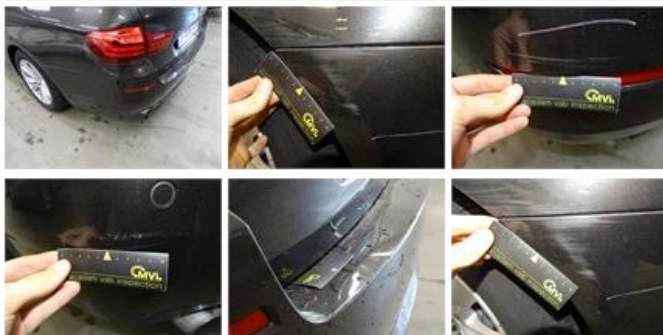
Bumper R, Dent(s) and scratch(es), LI - Repair and paint (complete)

254,16
